**COURT OF APPEALS, DIVISION III
OF THE STATE OF WASHINGTON**

WASHINGTON STATE DEPT. OF TRANSPORTATION, et al,

APPENDIX

Safety Report Walker v. Washington State Department of Transportation

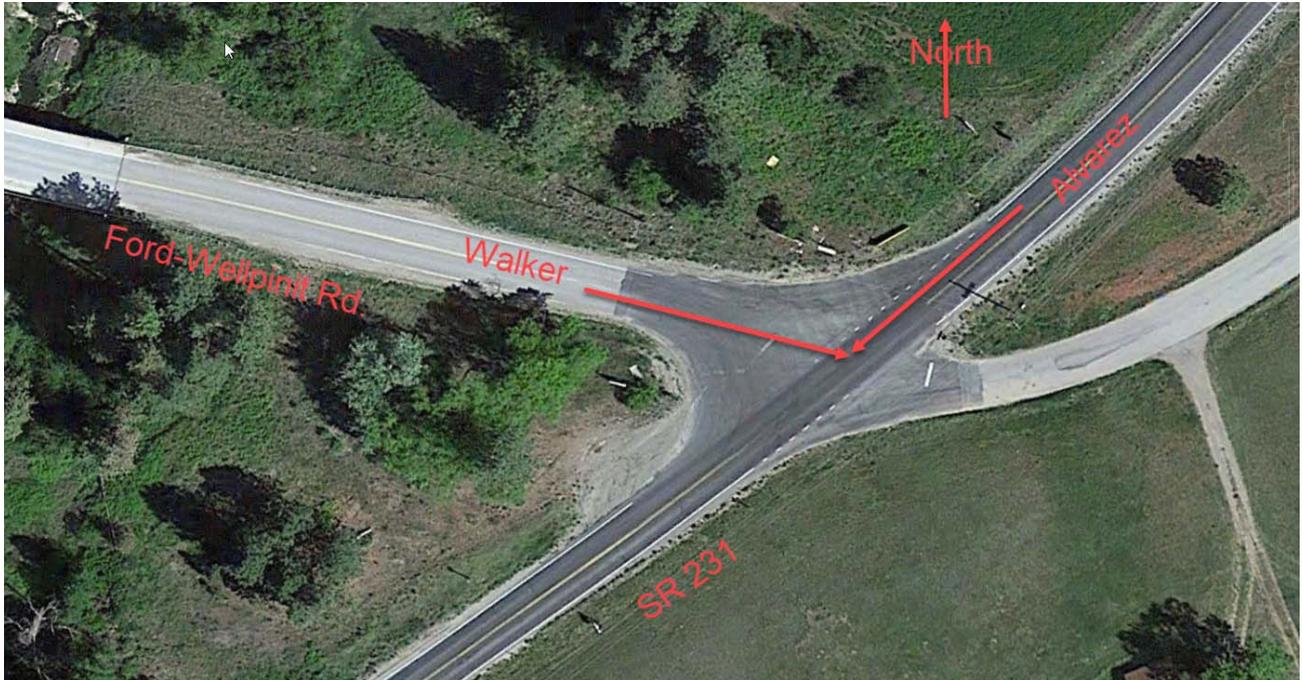
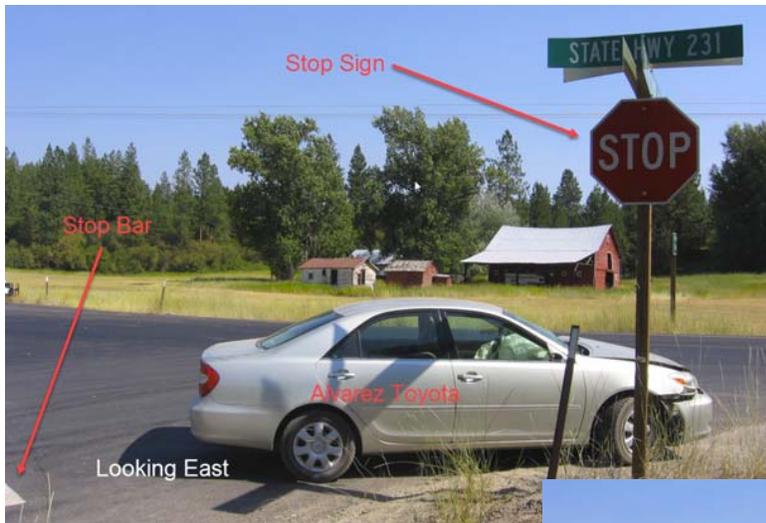
The intersection of SR 231 and Ford-Wellpinit Road is shown in the aerial image below. The posted speed limit on SR 231 was 55 mph. The posted speed limit on Ford-Wellpinit Road was 50 mph. A

vehicle traveling east on Ford-Wellpinit Road,¹ approaching SR 251, has a view of the approaching intersection that allows a driver to see the westbound stop sign, the newly painted stop bar on the westside of the intersection and the eastbound stop sign. The eastbound stop sign was erected near the south asphalt edge of Ford-Wellpinit Road and adjacent to the stop bar as can be seen in the photographs taken at the time of the

event. The aerial above illustrates that an eastbound vehicle would need to steer to the right if it were to continue across the intersection as the westbound lane is offset from the eastbound lane of travel. An eastbound driver has a clear view of the painted stop bar on the

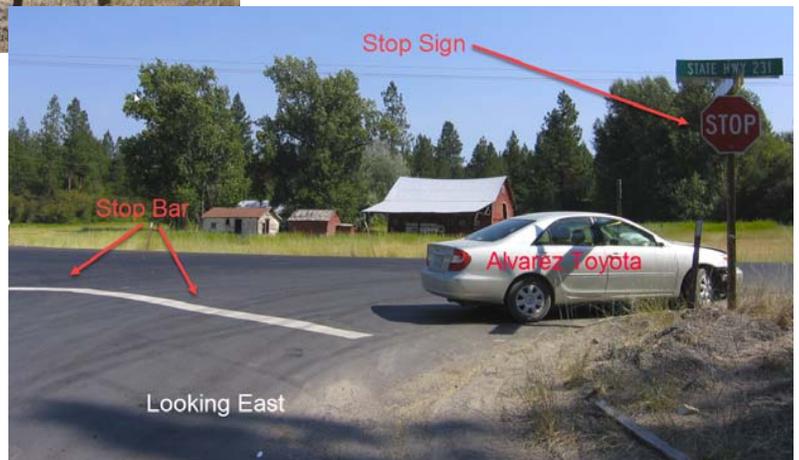
westside of SR 231 and a clear view of a stop sign for westbound traffic that is located across the

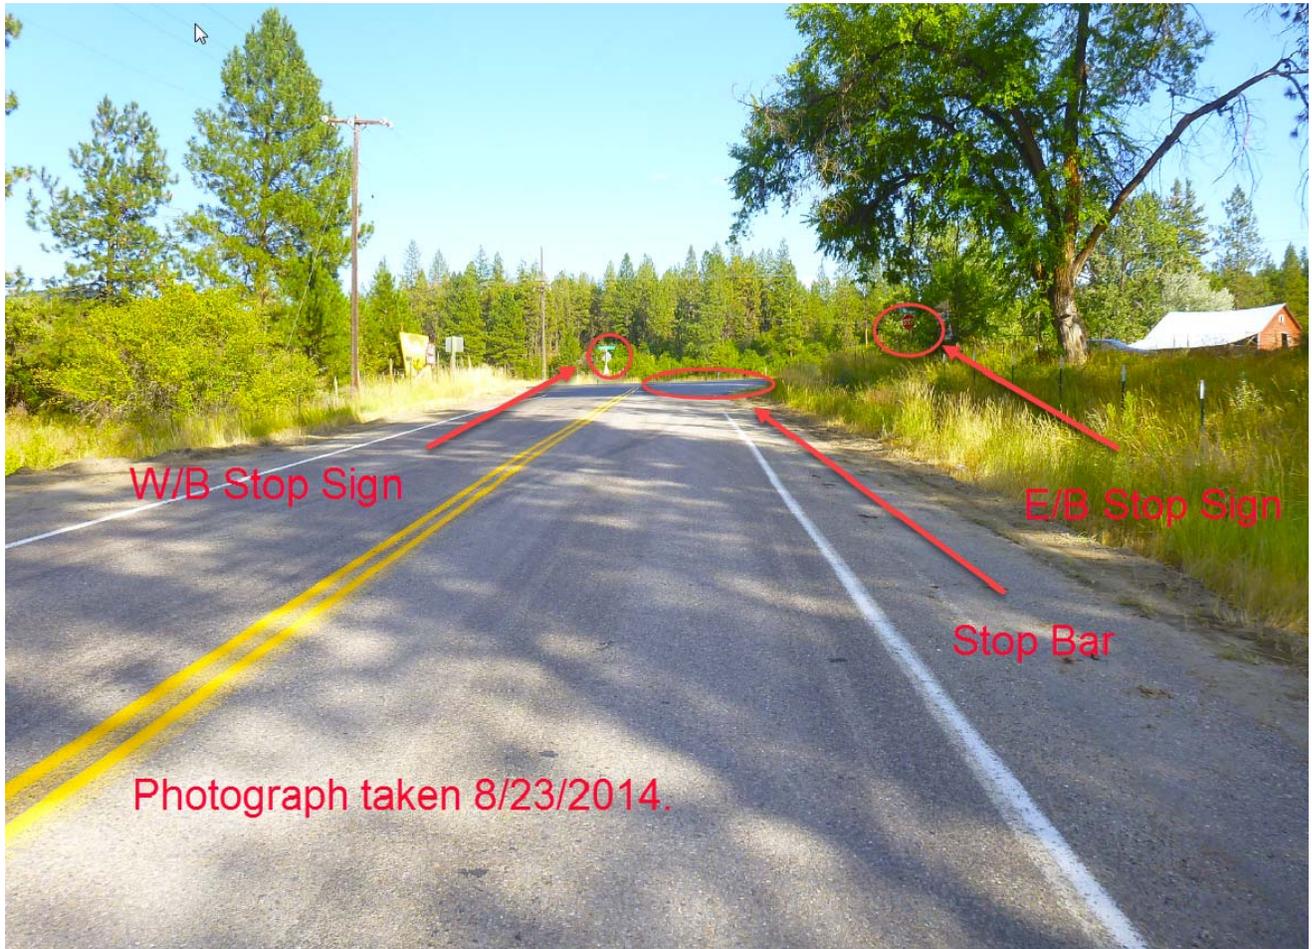
The image above was taken on August 23, 2014 and is labelled P1020764 from Walker photographs. The location of the photograph appears to be between 210-230 feet west of the stop bar for eastbound traffic.² The image was taken from the right wheel track and both stop signs (eastbound/westbound) and the eastbound stop bar can be observed. When comparing the Walker photographs with the scene images, there appears to be a growth to the bush that is just south of the green sign that was not evident in the scene images.

A photographic image cannot always represent what the eye actually detects since the eye and the brain function differently than the camera sensor and processing of the image. At least this image will give a minimum value for the ability to detect the stop sign.

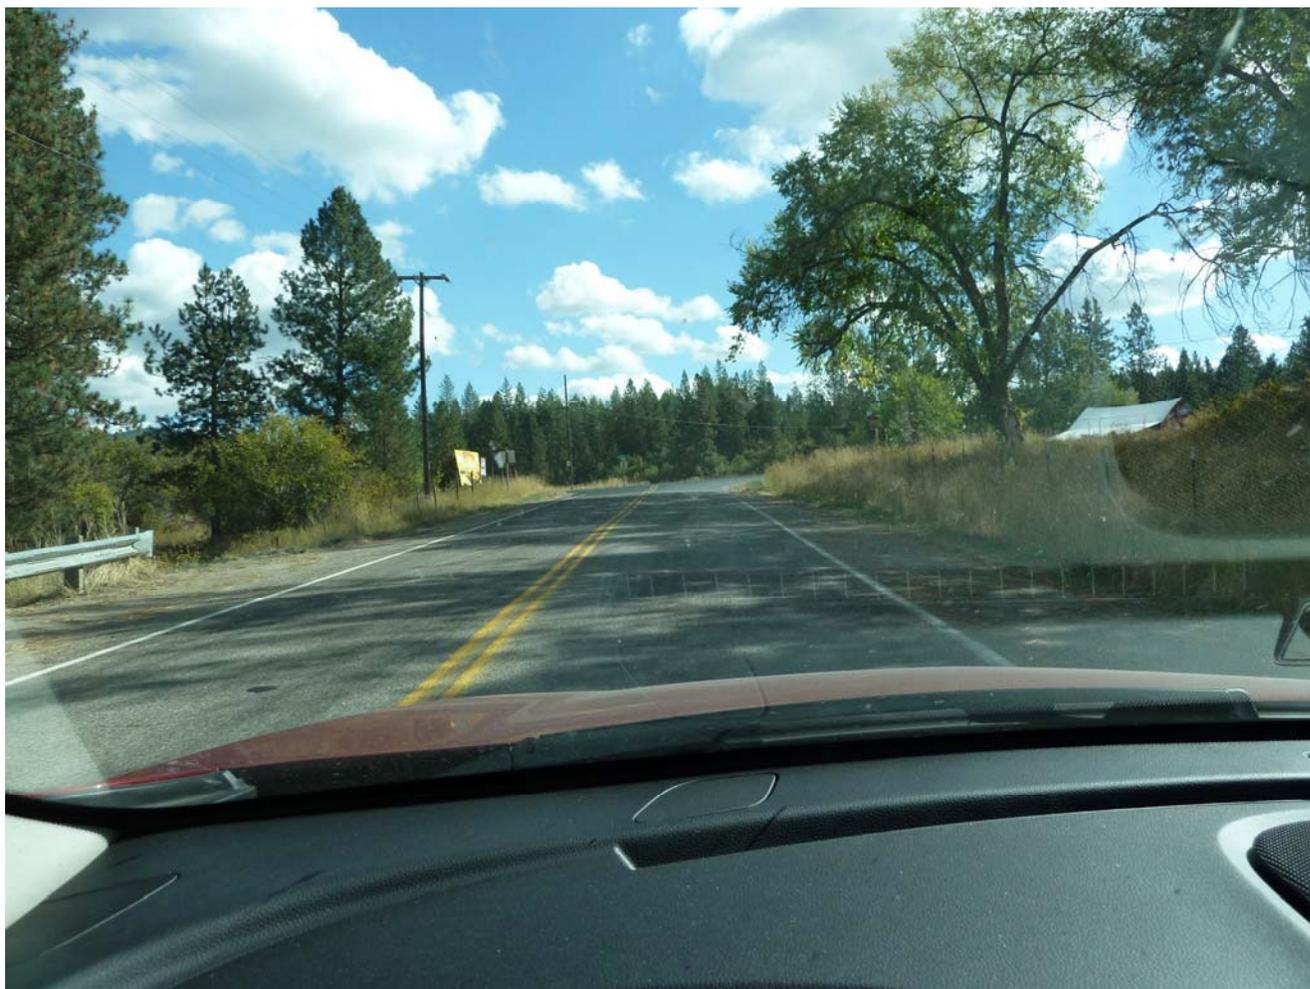
When I contacted the scene of the collision, I measured the dynamic sight distance (for a motorcyclist traveling in the left wheel track) to the stop sign based on the foliage as shown in the scene images and the Walker photographs that were taken over a year later. I determined the sight distance to the stop sign was in the range of 335 feet.

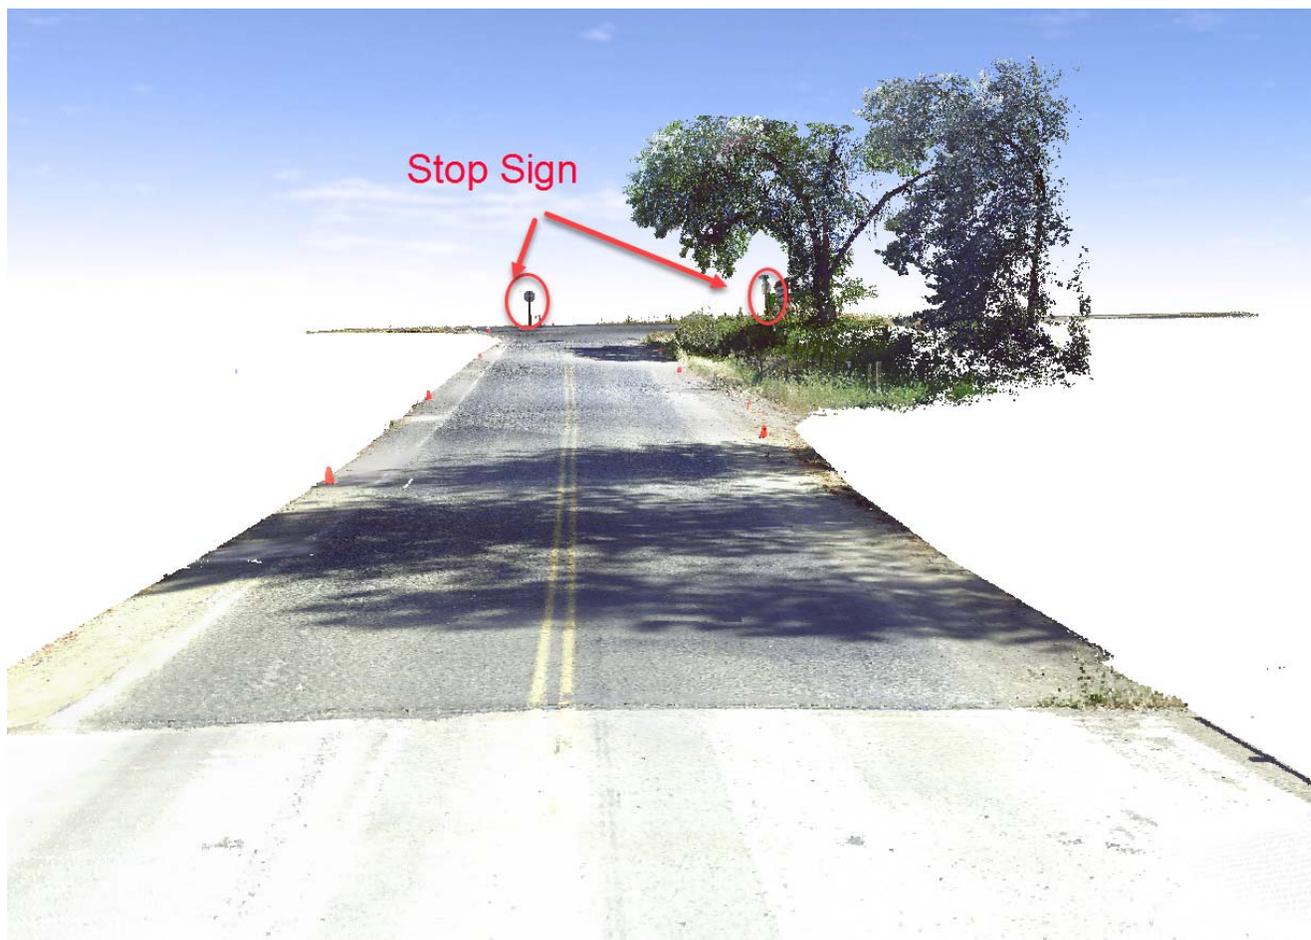
As part of the investigation, a 3-d scan of the scene was completed, and the excess foliage was removed in an attempt to duplicate the visibility of the eastbound stop sign at the time of the collision. A FARO scanner was used to document the roadway environment. The image below illustrates the approximate sight distance from the scan reconstruction. The actual dynamic sight distance was likely in the 325~ 350-foot range based on the simulated event.

It appears from the physical evidence that the stop sign was likely visible to Walker for well over 300 feet. This is consistent with the trooper's evaluation that the stop sign was "clearly" erected and the stop bar was "clearly" painted white.

In my opinion, the sight distance for the stop sign was likely in the 325~350-foot range. At the time of the collision, the intersection was apparent to Schildt as he knew something was coming up and was slowing and was able to stop even though he was not paying close attention to the route.

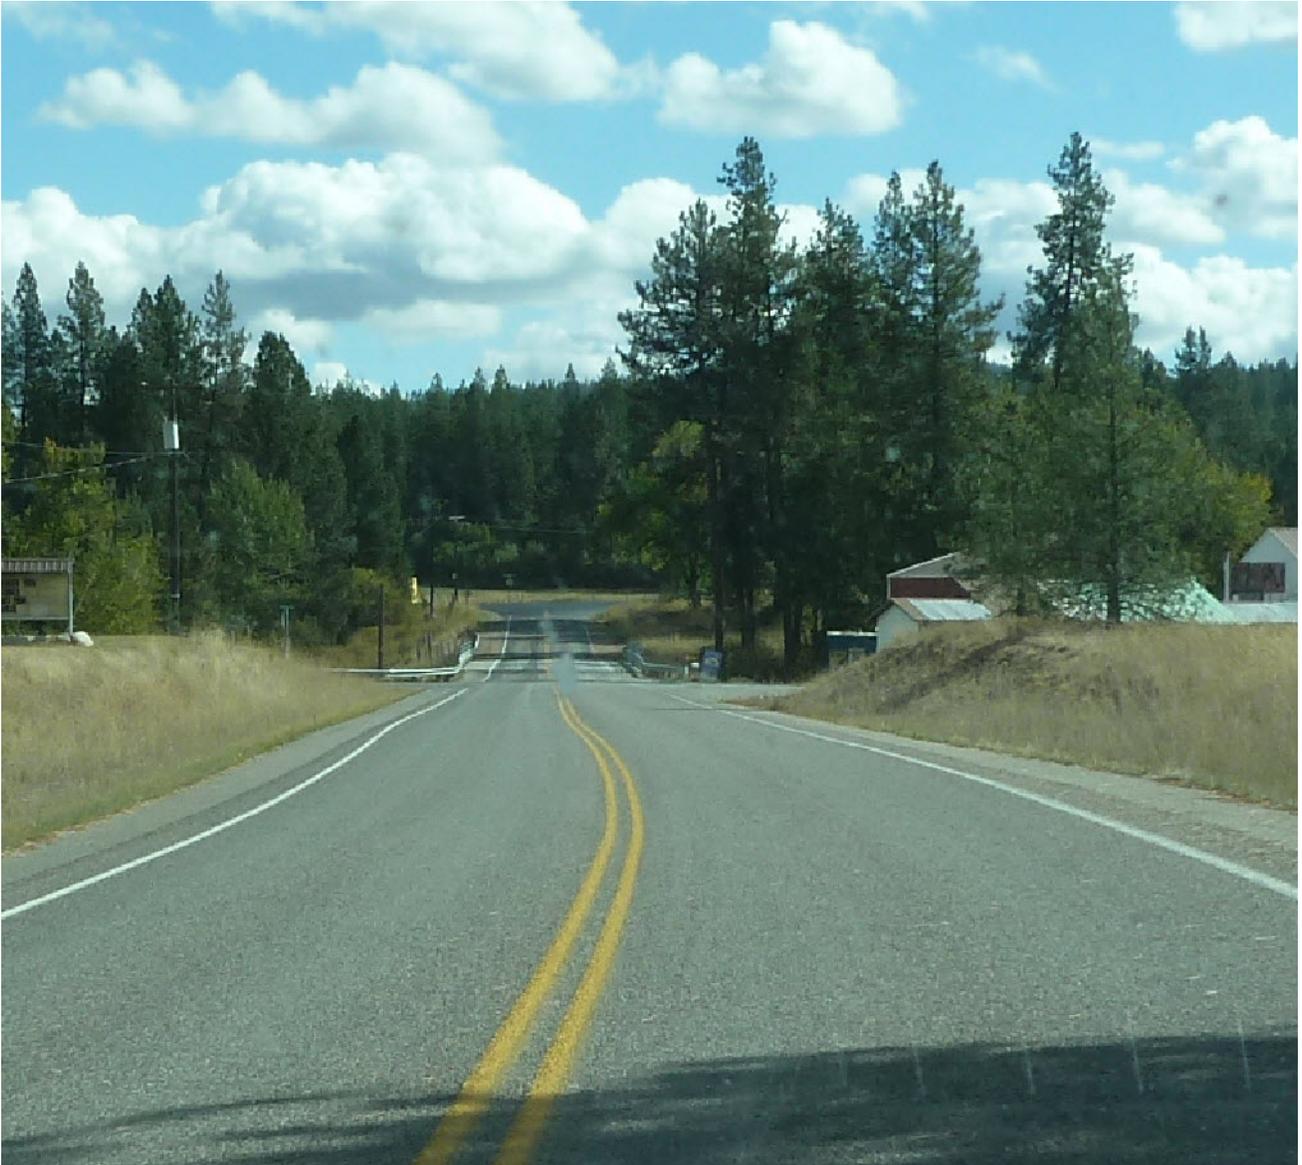
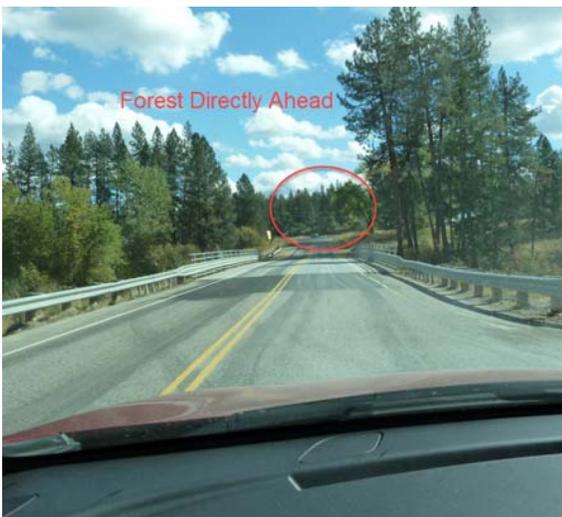
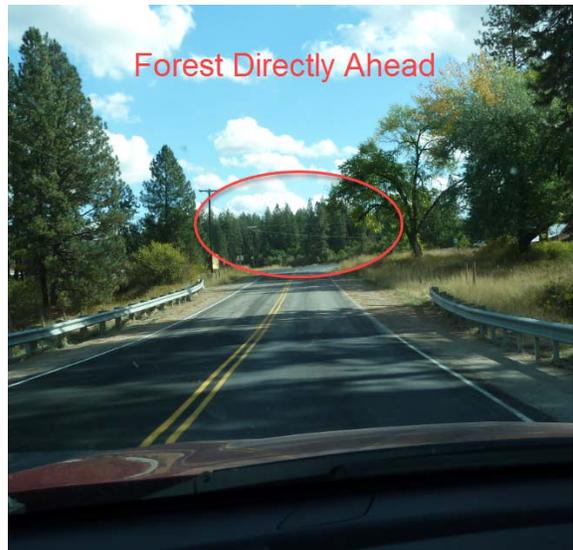
In the image (below) an approaching rider can see an intersection and buildings (store) in the immediate foreground that would constitute a potential hazard to a motorcyclist. Beyond the store is a change in surface conditions. The roadway transitions from asphalt to concrete and back to asphalt as the roadway crosses a bridge. Beyond the bridge it is obvious that the roadway terminates and transitions into a grassy field, not to mention the massive forest of trees that stand out in the background. The back of a stop sign can also be seen.

The approach photos show that the roadway is aimed directly at a forest of trees. Experienced motorcyclists are trained to watch tree lines to assist in determining the direction of the roadway. If the motorcycles were traveling at a constant speed of 50 mph. It would take them a little over 13 seconds to travel from the location 980 feet from SR 231, shown in the large photograph, to the stop bar.

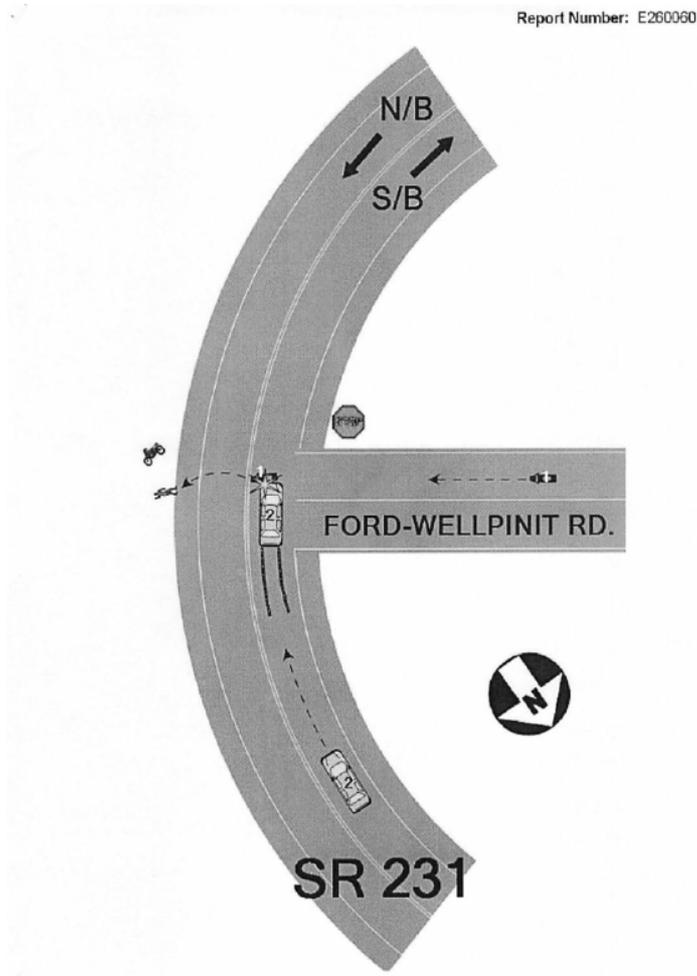
Figure 2: Diagram of accident²

On July 26, 2013 at 1:07pm, Mr. James Walker was driving his Kawasaki motorcycle eastbound on Ford-Wellpinit Road in Ford, Washington. According to the accident report, Mr. Walker failed to stop at the intersection with State Road 231 and collided with a Toyota Camry driven by Ms. Jaqueline Alvarez in the Southbound lane of State Road 231. Ford-Wellpinit Road had a stop sign at the intersection with State Road 231. State Road 231 had no traffic control. The posted speed limit for both roadways was 50 mph. In the accident Mr. Walker was ejected from the motorcycle and sustained severe injuries.

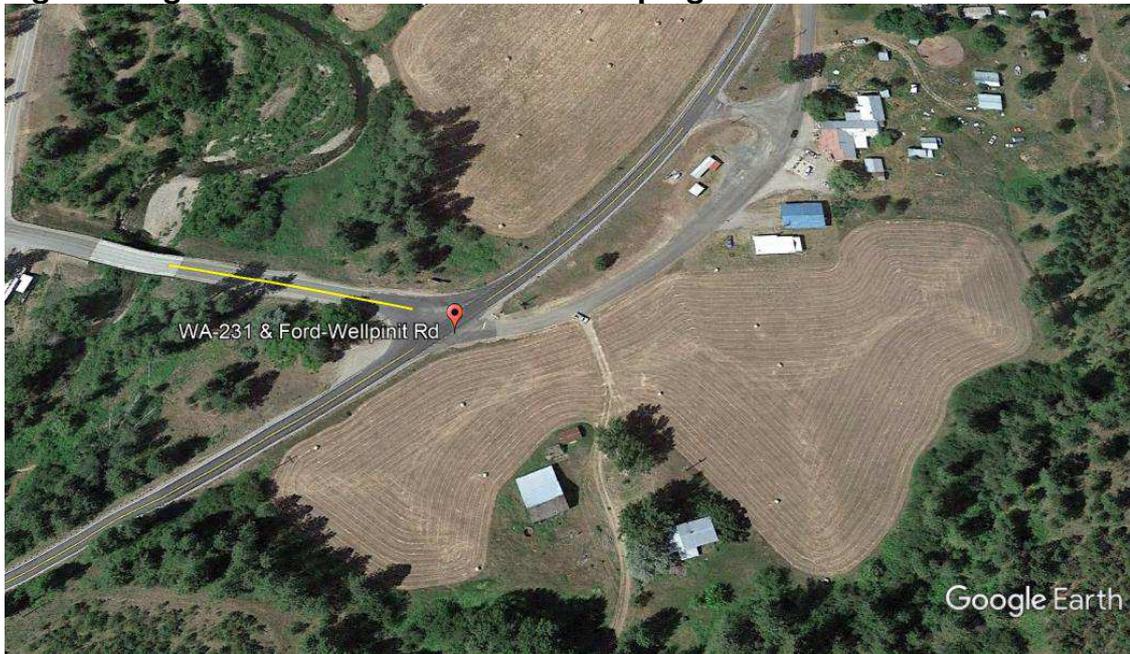
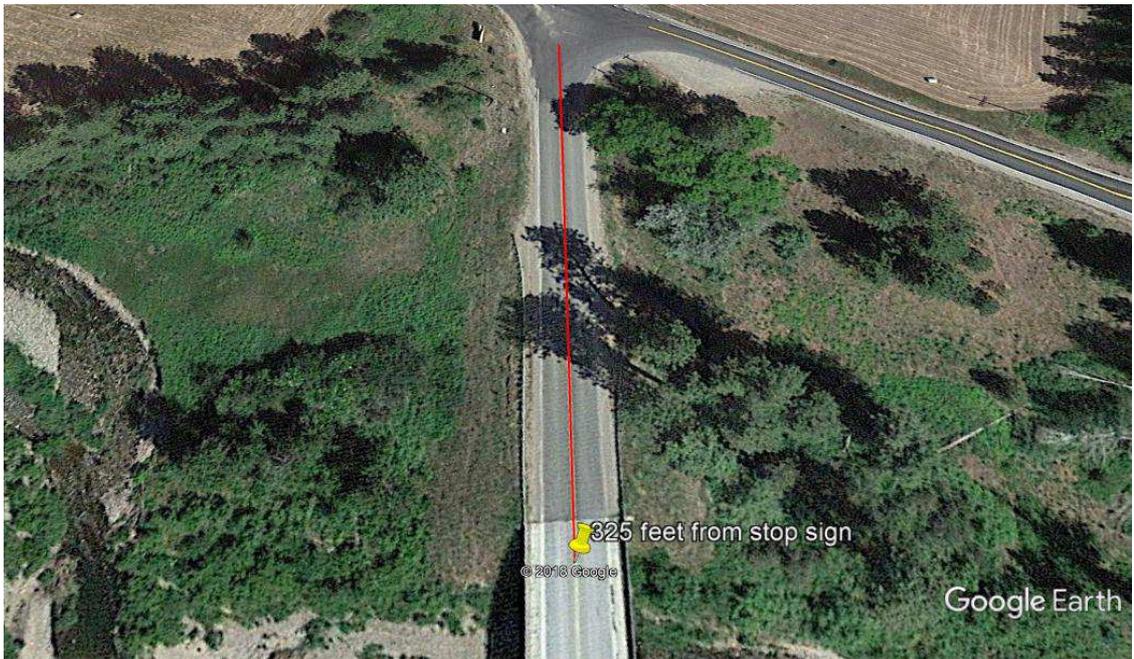
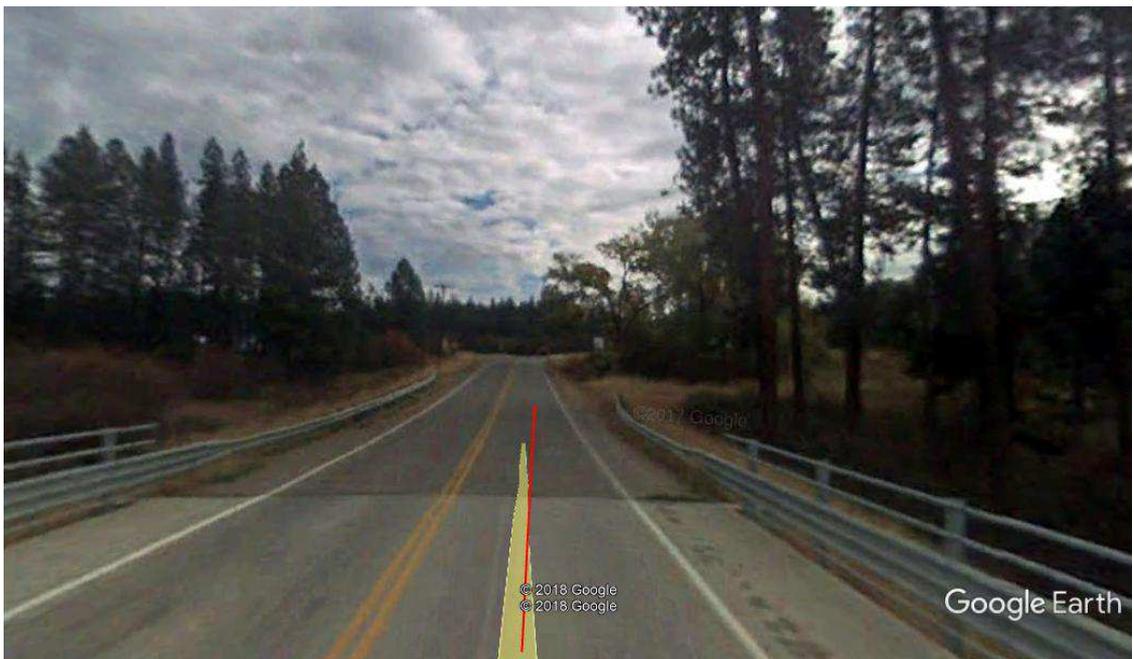
Figure 4: sight distance of 325 feet from stop sign

Note: position of 325 feet from stop sign

Note: View 325 feet from stop sign

Scenario I: Mr. Walker saw the stop sign on Ford-Wellpinit Road at the intersection with State Road 231 but failed to stop as required by law. According to the analysis by the expert witness John Hunter,³ the sight distance to the stop sign for a motorcyclist with the foliage present was between 325 to 350 feet. (figure 4) The plaintiff's expert arborist, Jim Flott, concludes that a "Siberian elm tree impacted the visibility of the stop sign negatively." The analysis of John Hunter takes this tree and other foliage into account in his calculation of a sight distance between 325 to 350 feet to the stop sign. Furthermore, according to Mr. Hunter, a motorcycle with an experienced rider can stop from 50 mph in under 200 feet without leaving a tire mark. This assumes a one second perception-reaction time period and a controlled brake application with both brakes. This stopping distance is consistent with data from Ride Smart Florida, which is based on a study by the NHTSA.⁴ (figure 5) According to Ride Smart Florida, a

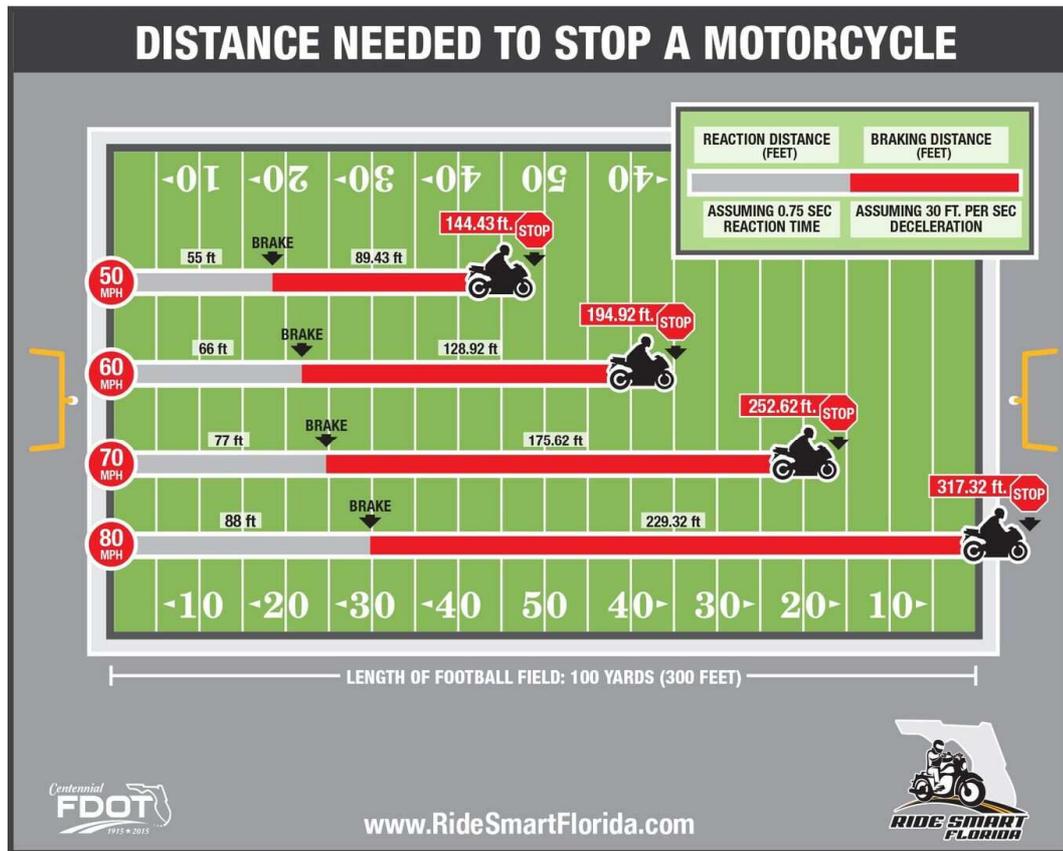
Figure 5: Motorcycle stopping distance

For more information, please see "A Study of Motorcycle Rider Braking Control Behavior (2011)" by the NHTSA

Note: At 50 mph: reaction brake time is 0.75 seconds, braking stop time is 2.44 seconds. Total time is 3.19 seconds.

motorcycle traveling at 50 mph needs approximately 143 feet and 3.19 seconds to stop. According to the report this distance includes 55 feet reaction distance and 89.43 feet braking distance. This is consistent with a study by bikesafer.com (with Montreal Promocycle Foundation),⁵ which calculates the braking distance with ABS brakes and reaction time is 141.64 feet and 3.24 seconds to stop. It is possible that Mr. Walker's lack of experience with his high-performance motorcycle contributed to the accident. The operators of this type of motorcycle tend to lean forward over the handle bars for a more aerodynamic profile, which can reduce the sight distance. (see photographs of similar motorcycles in figure 9) However, in each of these scenarios, it is clear that Mr. Walker had sufficient sight distance to stop before entering the intersection. In this case, given the other vehicle was obeying the required traffic laws, Mr. Walker would be at fault for the accident for not complying with the applicable traffic laws.

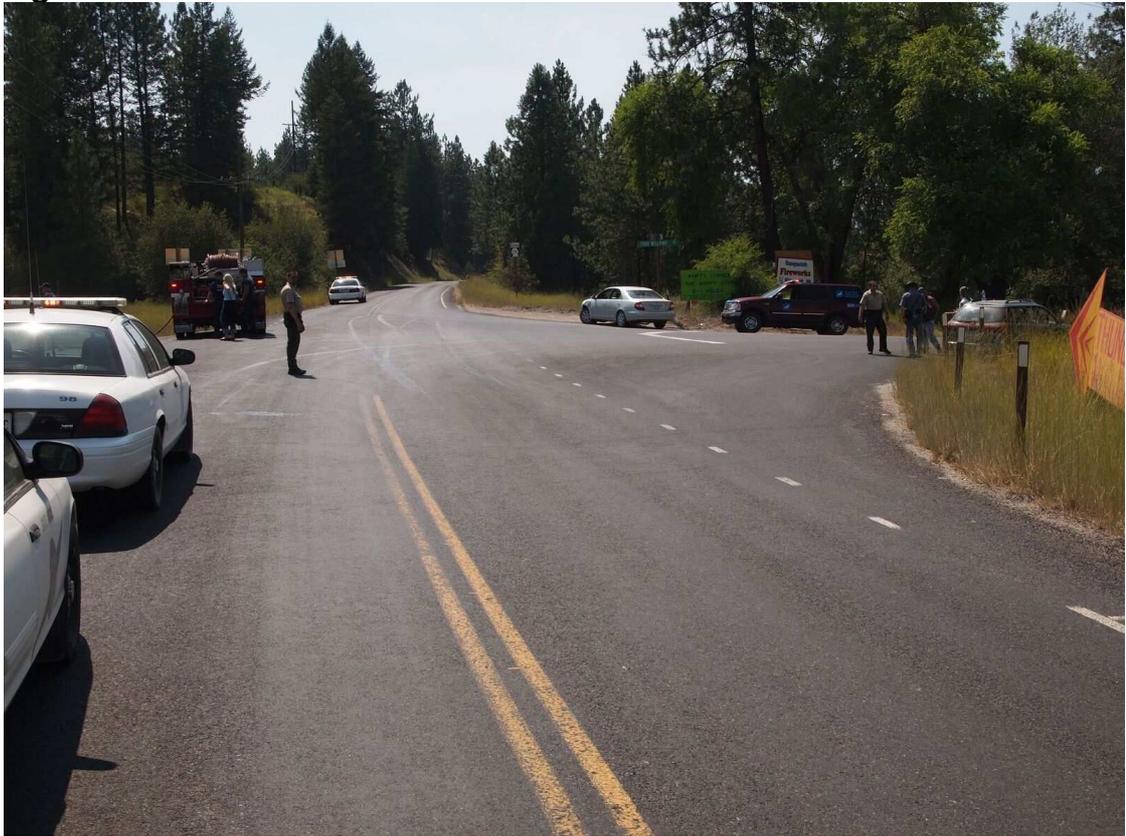
Figure 7: Visual cues of intersection

Note: White line that divides State Road 231 from Ford-Wellpinit Road

Scenario 2: Mr. Walker did not see the stop sign on Ford-Wellpinit Road at the intersection with State Road 231. Mr. Walker may have not seen the stop sign because he was not paying attention to the road signage or alternatively due to his eyesight issue. It was noted in the deposition of Joellen Gill that Mr. Walker has amblyopia⁶ and chose not to wear glasses to correct the deficiency (see figure 6). In addition to the stop sign, Mr. Walker ignored a number of other visual cues that indicated that the road conditions were changing, such as the freshly painted stop bar⁷, stop sign on other side of the road, the white line that divides State Road 231 from Ford-Wellpinit Road, the road seemingly ending in a field and tree line. (see figure 7) Mr. Schildt, Mr. Walker's

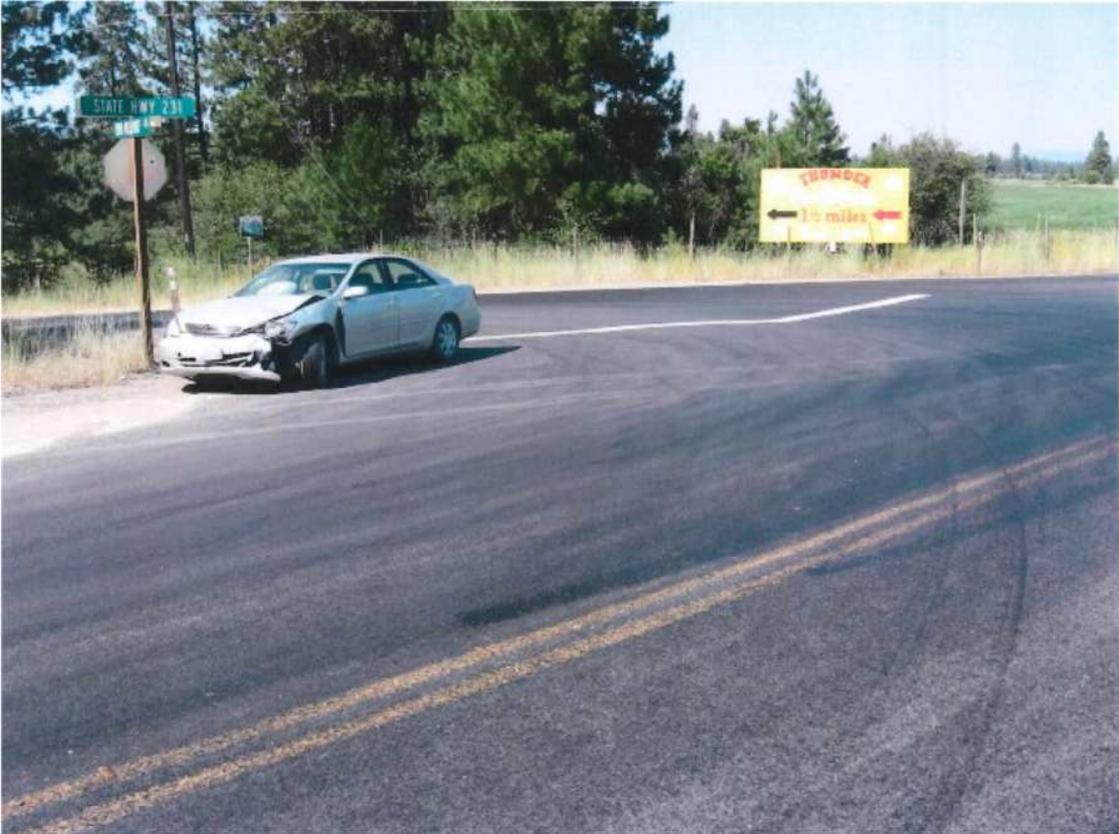
Note: Freshly painted stop bar⁸

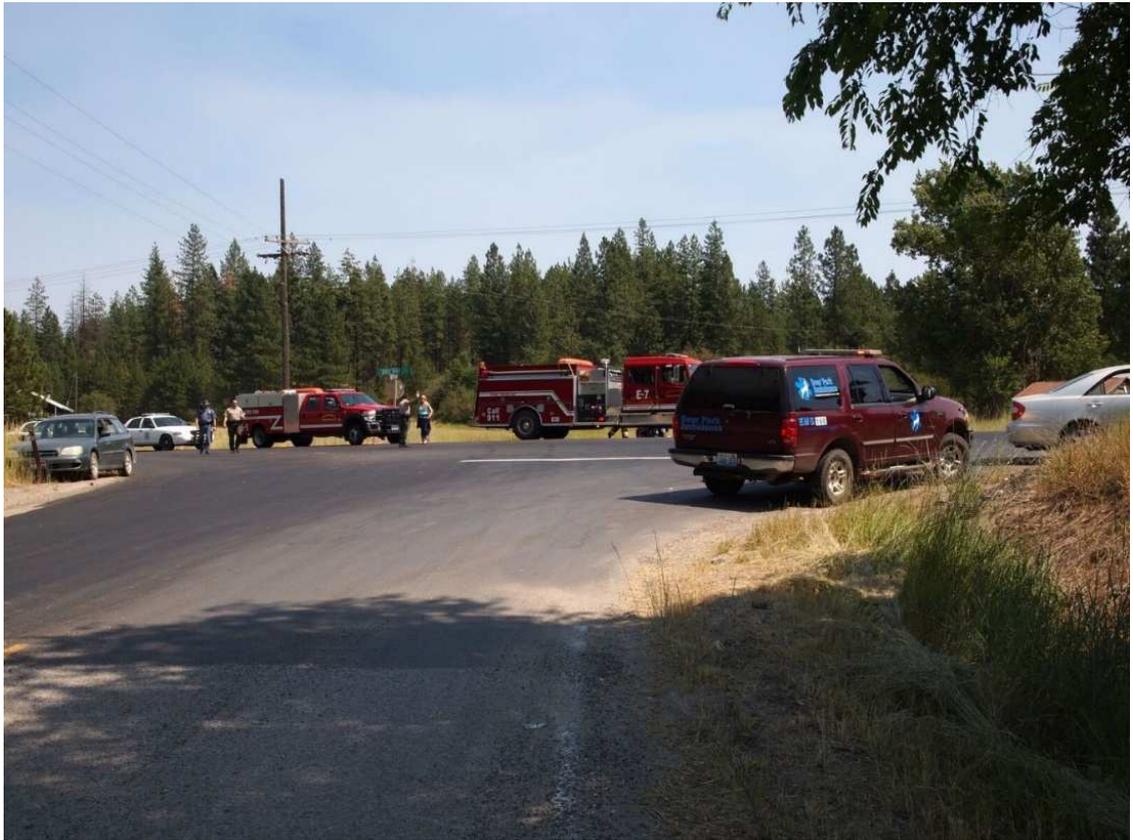
Note: Freshly painted stop bar

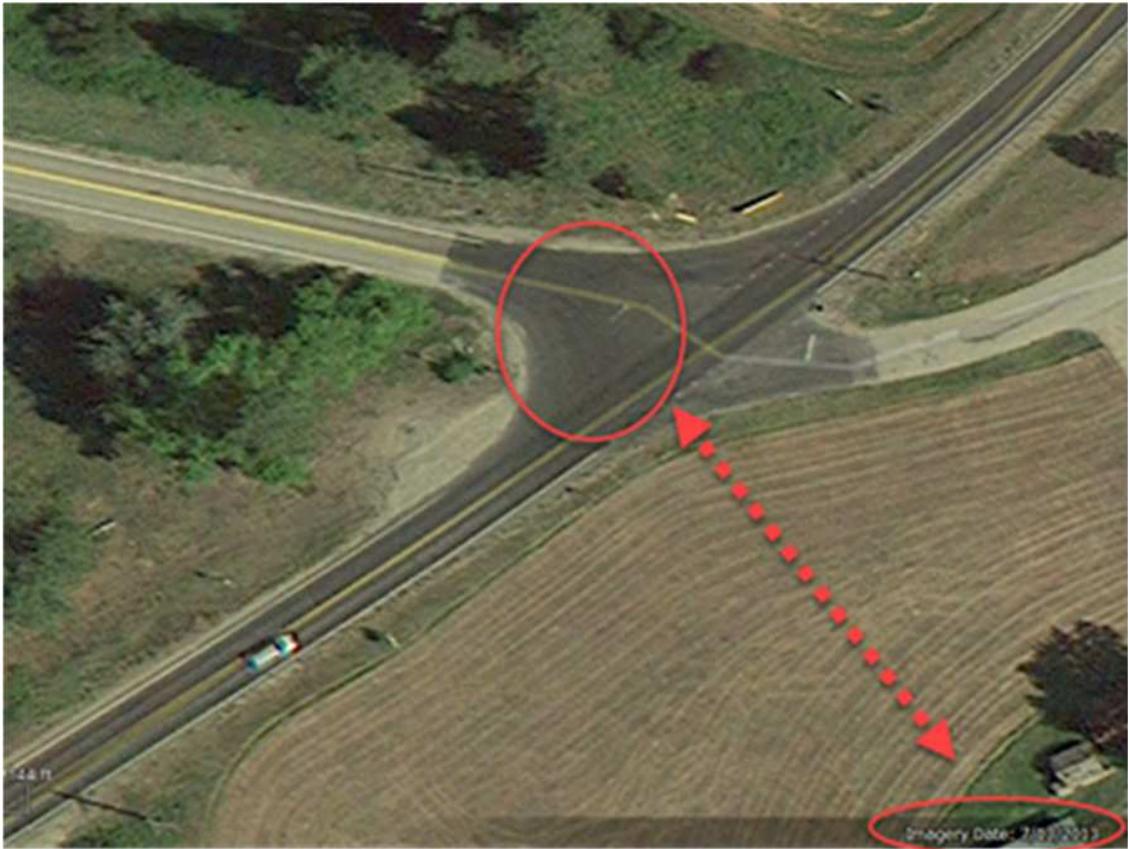
Note: Historic view dated July 13, 2013 (before accident) which shows a very worn stop bar, indicated that the stop bar was freshly painted prior to date of accident on July 26, 2013.

⁷ Figure 7 shows a very worn stop bar on July 13, 2013, indicating it was freshly painted before the accident on July 26, 2013.

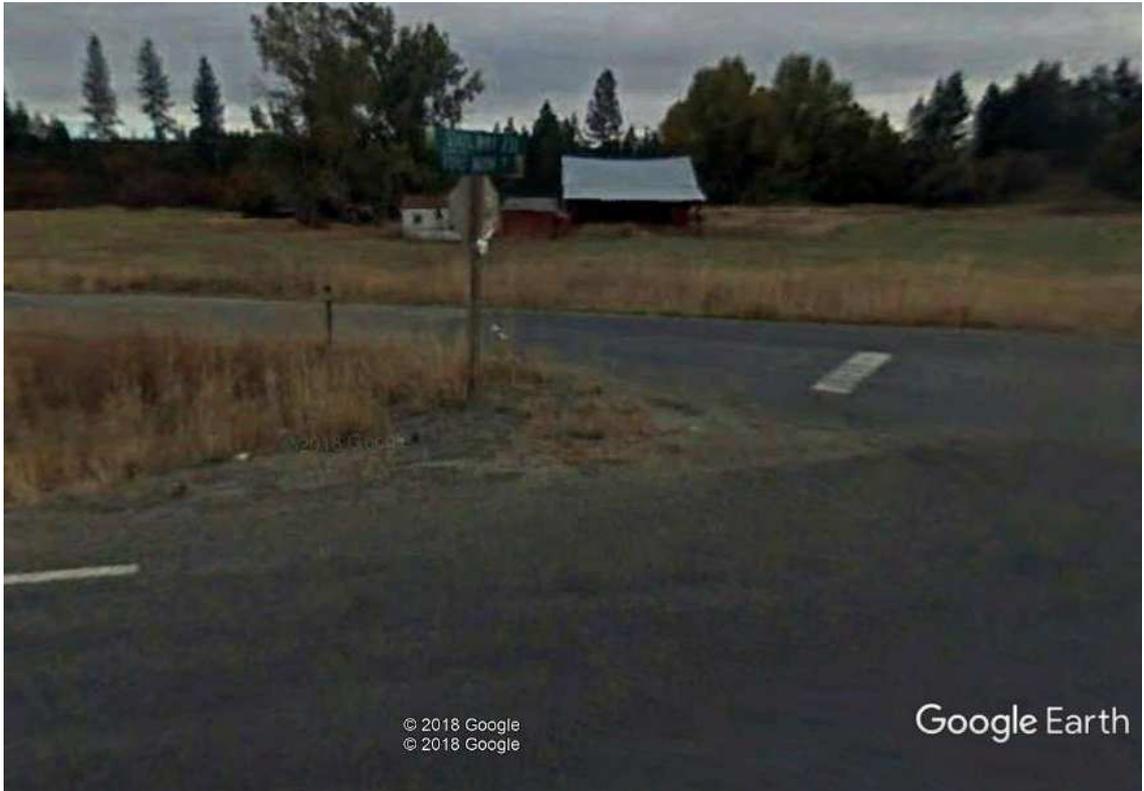
Note: Stop sign and stop bar on opposite side of the intersection⁹

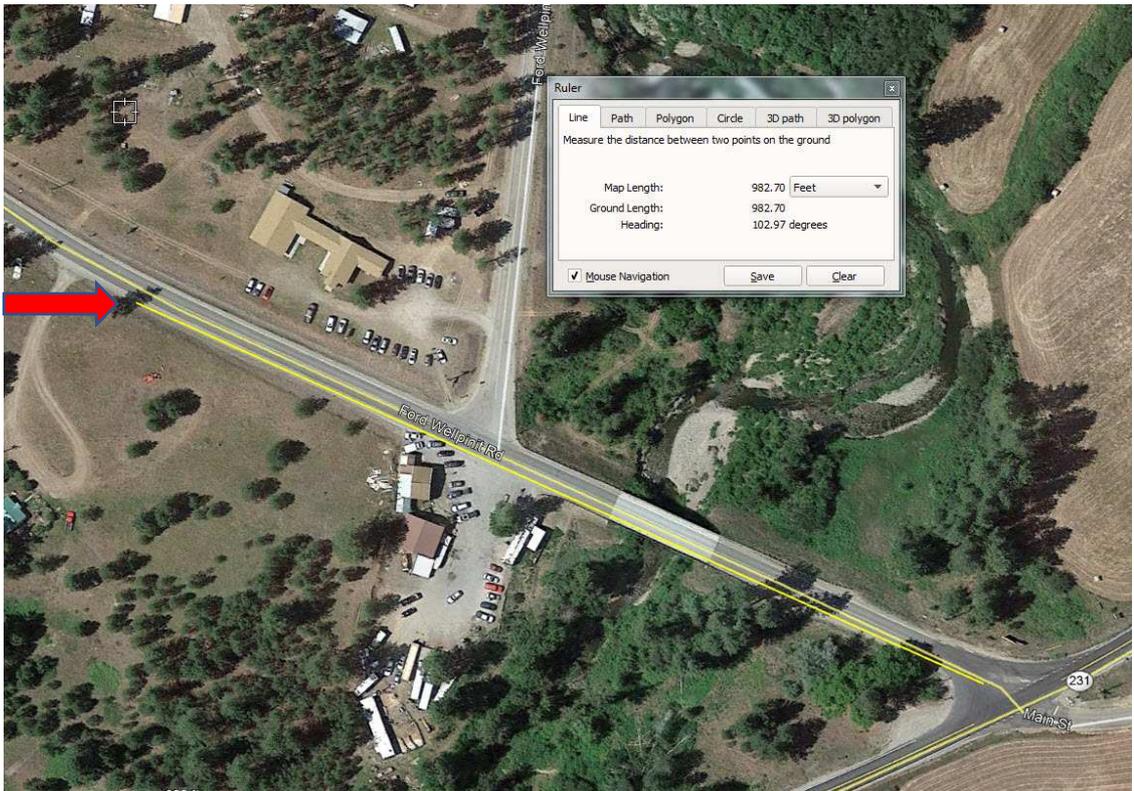
Note: Aerial view showing position approximately 980 feet from stop sign

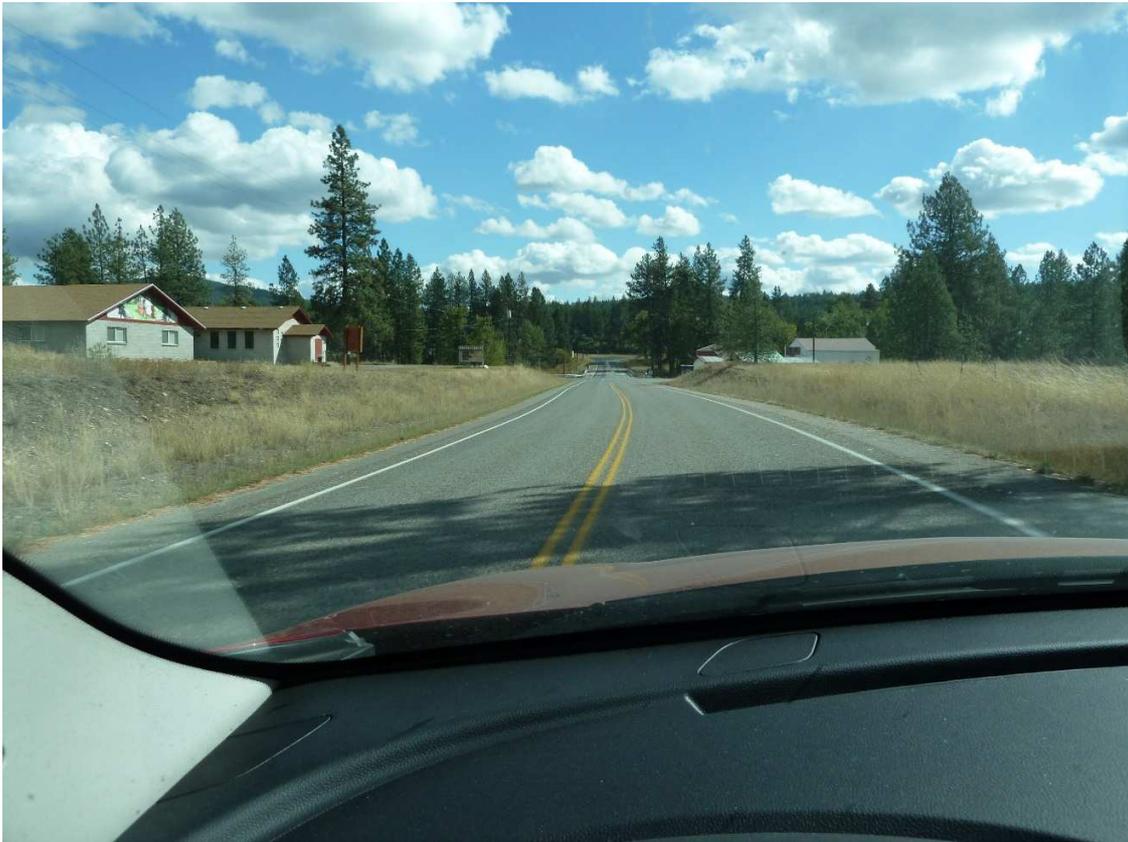
Note: Mr. Walker view approximately 980 feet from stop sign

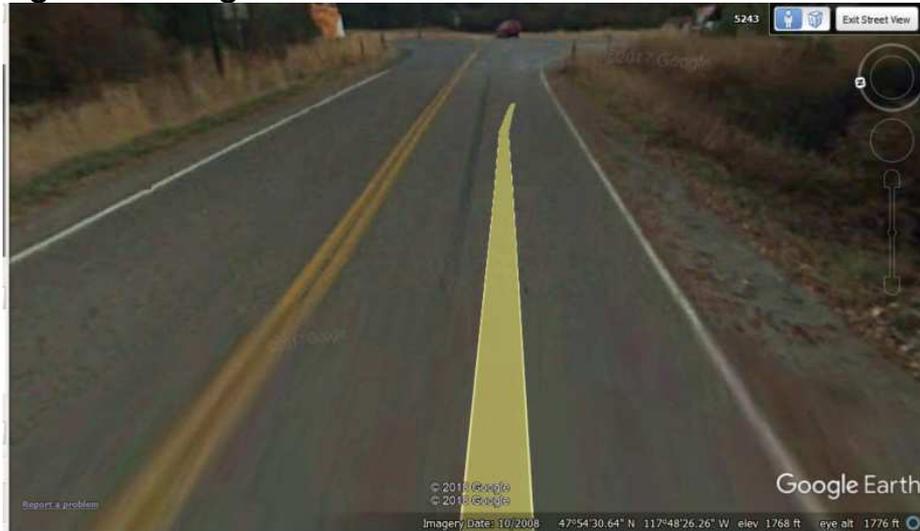
Figure 10: Google Earth elevation calculations

Note: elevation = 1768 ft

According to AASHTO, A Policy on Geometric Design of Highway and Streets, the required stopping sight distance on level roadways at 50 mph is 425 feet (see figure 9). Note that the elevation of Ford-Wellpinit Road approaching the intersection with State Road 231 is negligible, thus a grade = 0% is assumed for this calculation. (see figure 10). According to the analysis by the expert witness Mr. John Hunter, the sight distance to the stop sign for a motorcyclist with the foliage present was between 325 to 350 feet. Therefore, the placement of the sign was in violation of the AASHTO minimum sight distance requirement.

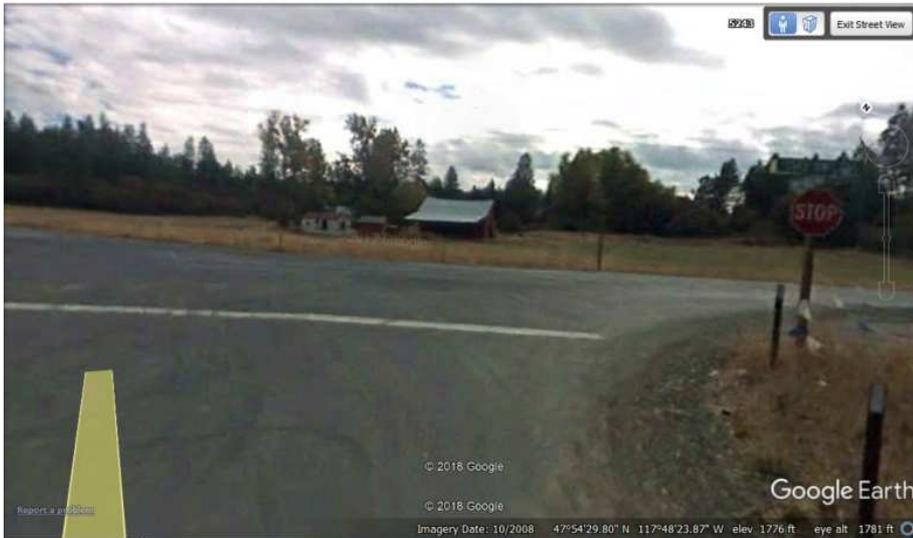
Note: elevation = 1776 ft

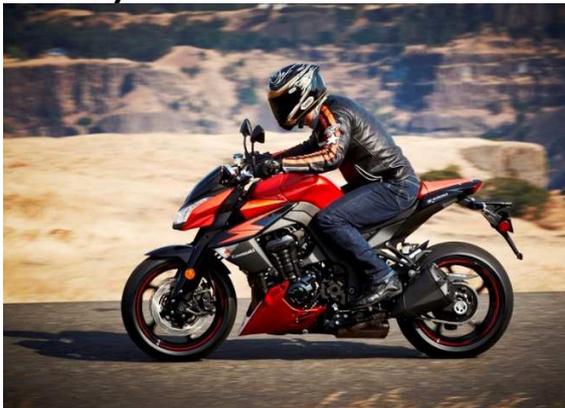
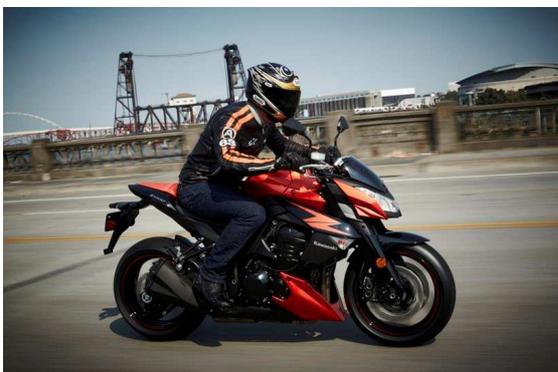
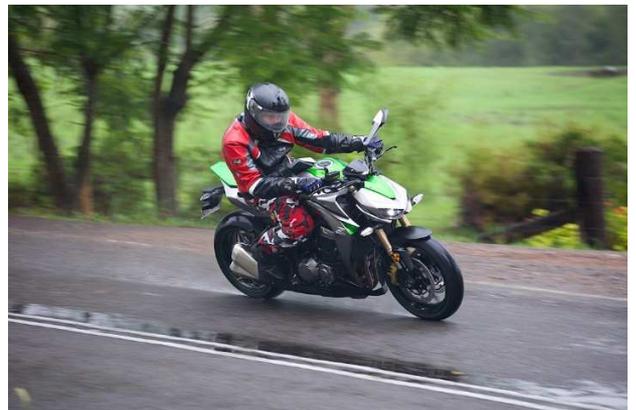
Figure 13: Pictures of similar motorcycles

- Kawasaki 2012
- VIN Number: JKAZXCH19CA003294
- Make: KMCU
- Model: ZX1000
- Style: MC
- Front Brakes: Dual 300 mm petal-type rotors with radial-mount four piston Calipers
- Rear Brakes: Single 250 mm petal-type rotor with single-piston caliper
- A high-performance motorcycle often driven at excessive speeds by their owners. The bike looks like the batman bike, and the operators tend to lean forward over the handle bars for a more aerodynamic profile.

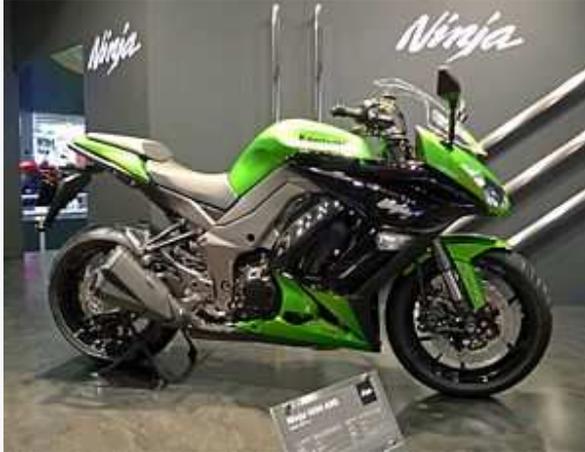
Kawasaki Ninja 1000

Manufacturer	Kawasaki Motorcycle & Engine Company
Also called	Kawasaki Z1000S/Z1000SX
Parent company	Kawasaki Heavy Industries
Production	2011–present
Class	Sport touring
Engine	1,043 cc (63.6 cu in) liquid-cooled 4-stroke 16-valve DOHC inline-four
Bore / stroke	77.0 mm × 56.0 mm (3.03 in × 2.20 in)
Top speed	152.8 mph (245.9 km/h)
Power	103 kW (138 bhp) @ 9,600 rpm (claimed) 93.3 kW (125.1 hp) @ 9,000 rpm(rear wheel)
Torque	98.54 N·m (72.68 lb·ft)(rear wheel) @ 8,800 rpm
Transmission	6-speed constant mesh
Suspension	Front: Inverted 41 mm (1.6 in) telescopic fork with stepless compression and rebound damping, adjustable spring preload Rear: Swingarm with horizontal monoshock with stepless rebound damping, remotely adjustable spring preload
Brakes	Front: Four-piston caliper with dual 300 mm (11.8 in) discs Rear: Single-piston caliper with single 250 mm (9.8 in) disc
Tires	Front: 120/70-17 Rear: 190/50-17

Rake, trail	24.5°, 100 mm (4.0 in)
Wheelbase	1,450 mm (56.9 in)
Dimensions	L: 2,110 mm (82.9 in) W: 790 mm (31.1 in) H: 1,230 mm (48.4 in)
Seat height	820 mm (32.3 in)
Weight	228.0 kg (502.7 lb) (2011–2016) (wet) 235 kg (518 lb) (2017–) (wet)
Fuel capacity	19 l; 4.2 imp gal (5.0 US gal)
Related	Kawasaki Z1000
