**COURT OF APPEALS, DIVISION III
OF THE STATE OF WASHINGTON**

WASHINGTON STATE DEPT. OF TRANSPORTATION, et al,

APPENDIX

Safety Report Walker v. Washington State Department of Transportation

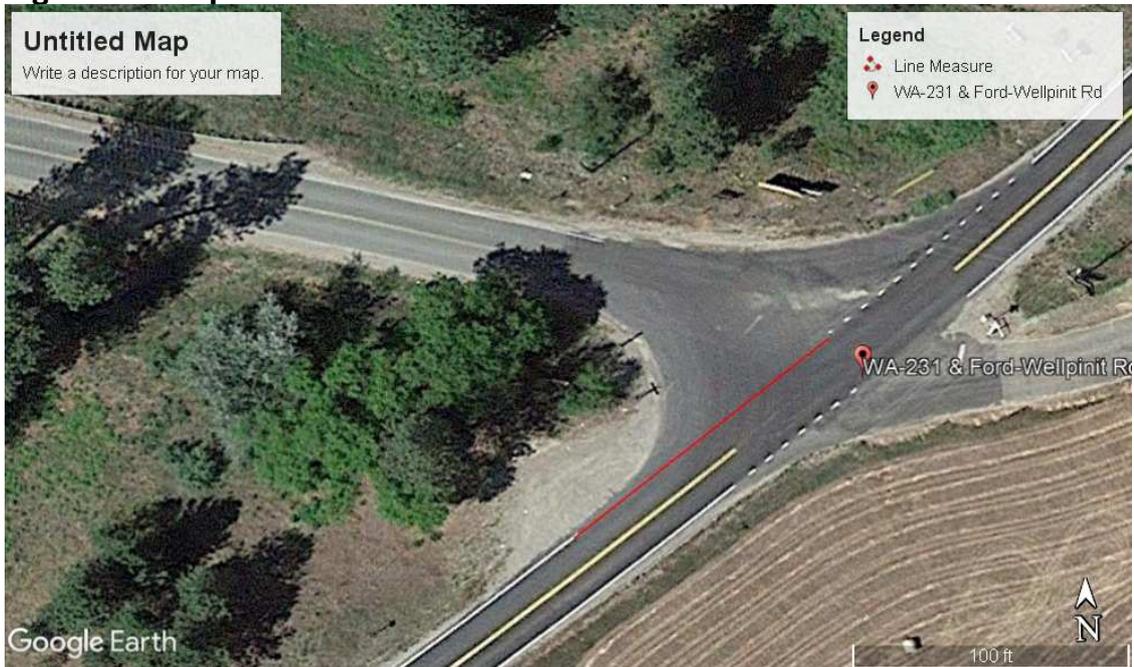
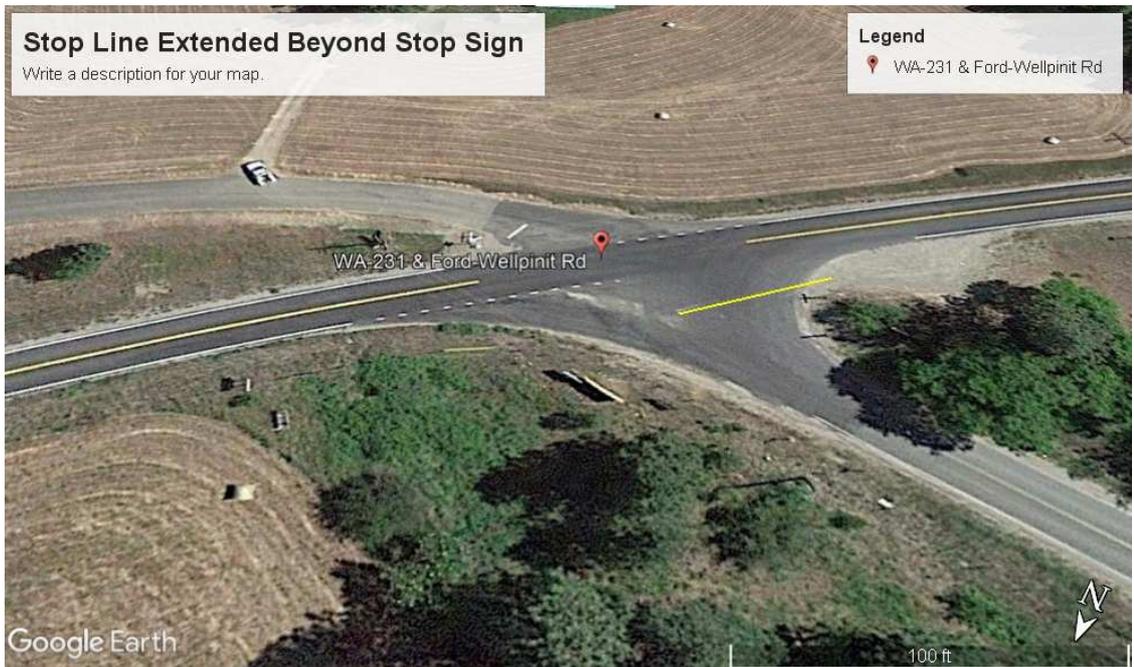
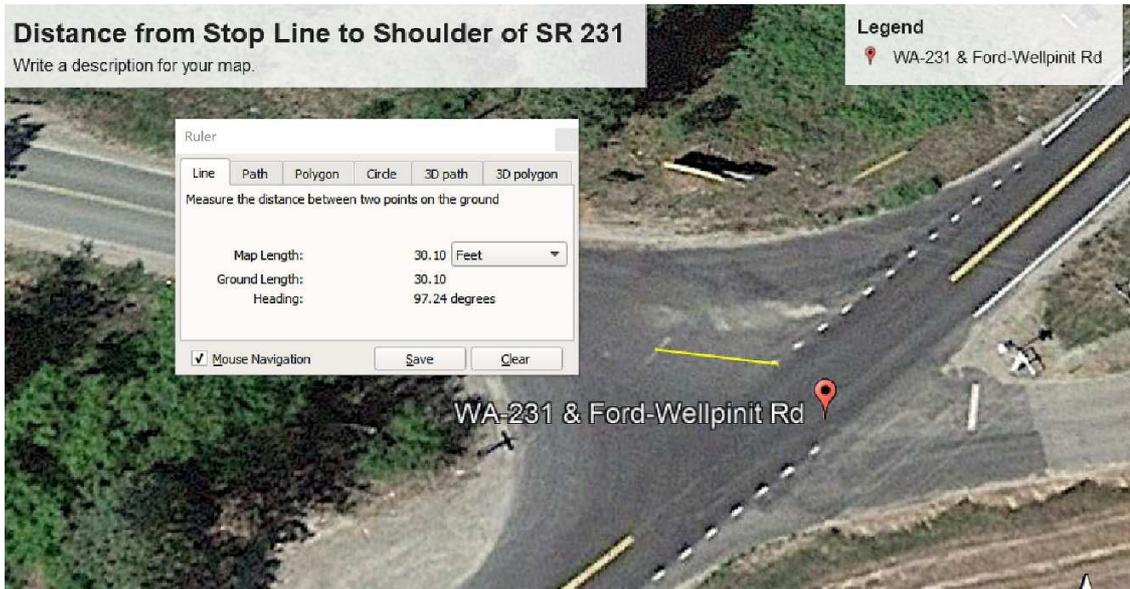
Figure 14. Stop Line in relation to SR 231 extended shoulder line

Furthermore, if Mr. Walker had slowed his vehicle to stop at the stop line or at the shoulder line, Ms. Alvarez who was traveling at 50 mph would have past the point where Mr. Walker would have intersected with SR 231.

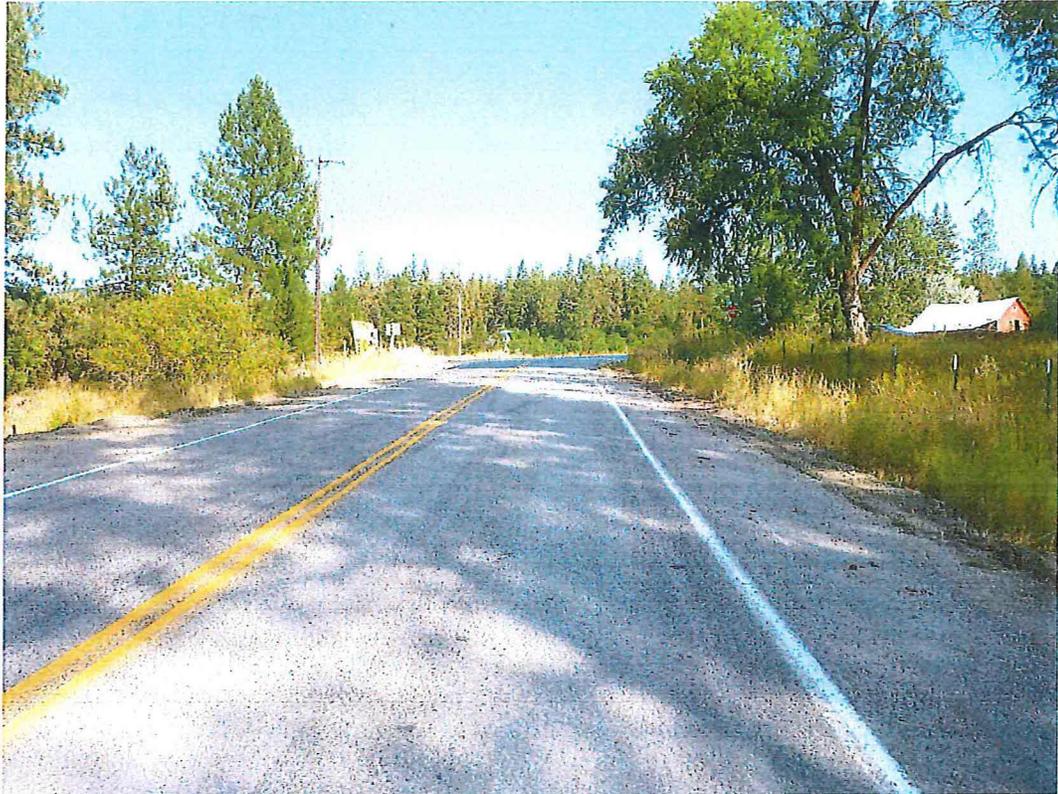
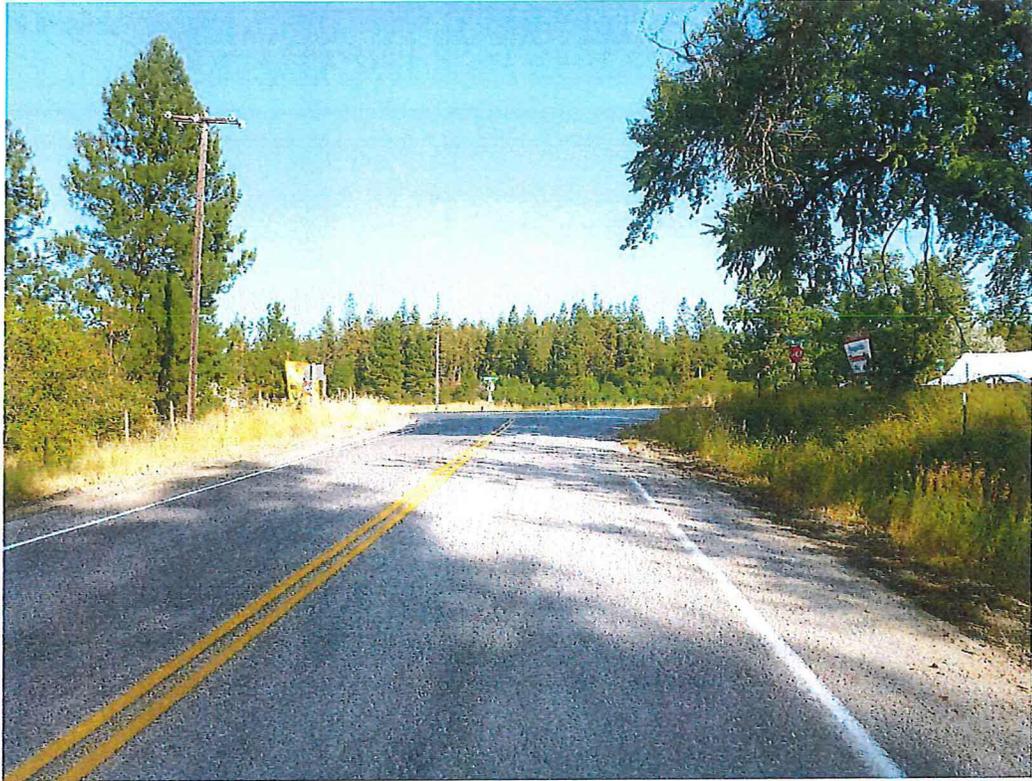
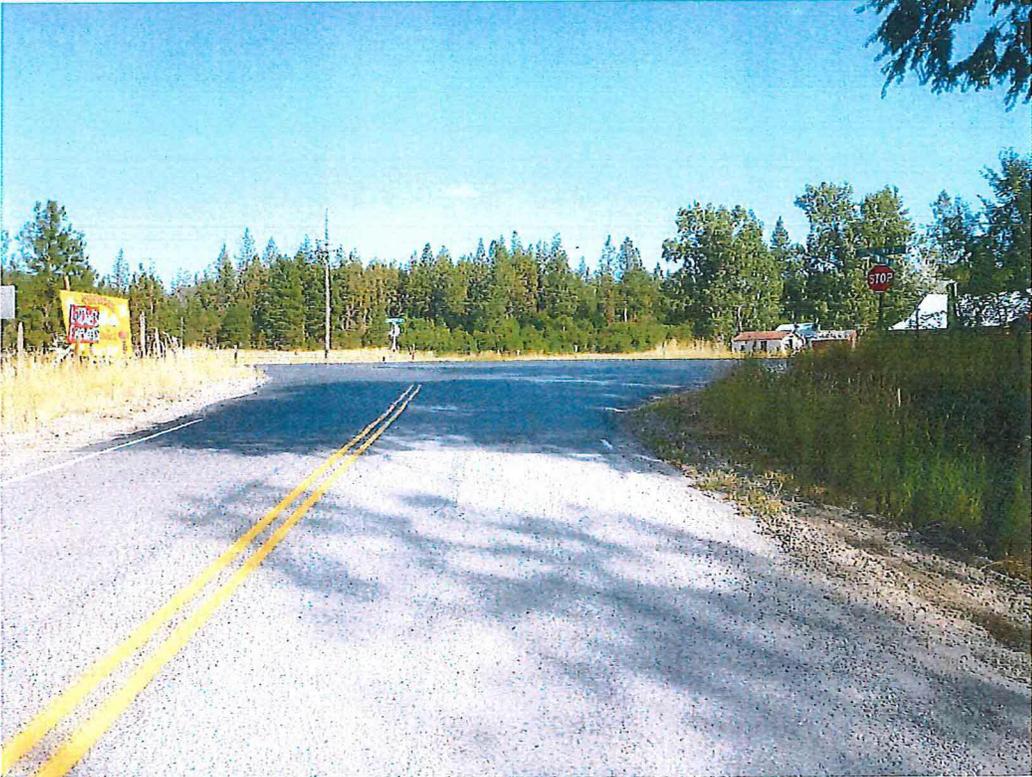
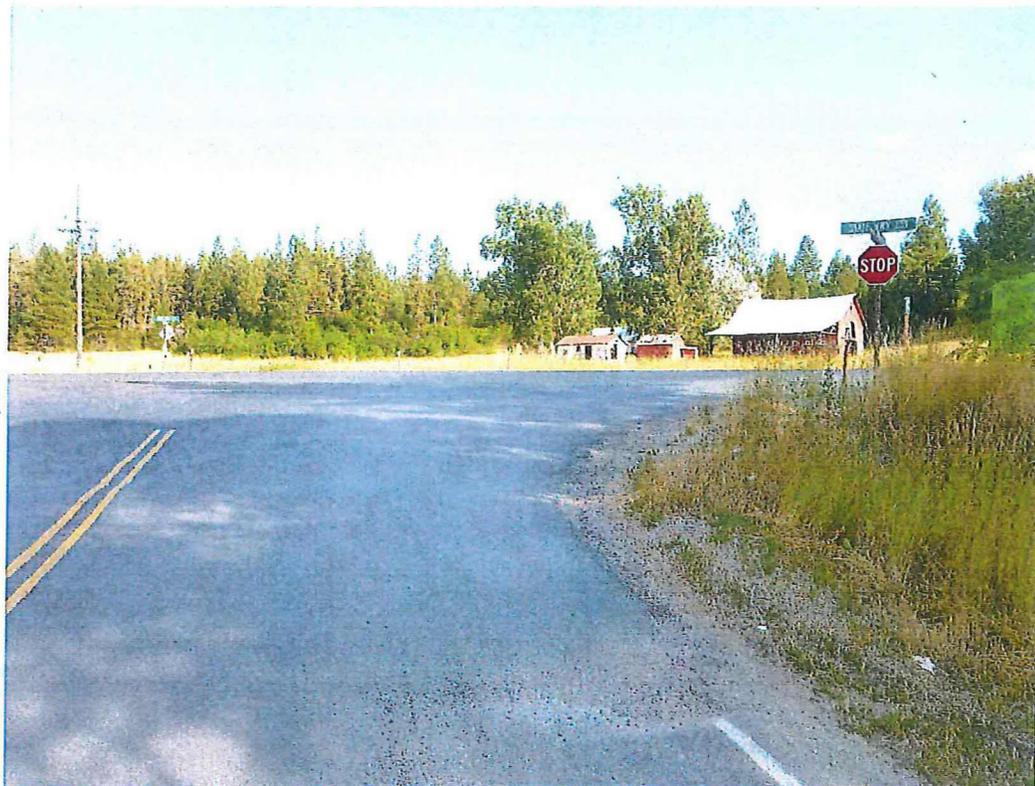
4. Below is a series of photographs that help illustrate the distinction I made in my testimony. The photographs are taken from Ford Wellpinit Road approaching SR 231. This is the route Mr. Walker traveled on the day of the accident. These photographs were taken a year after the accident. So, the obstruction of the visibility of the stop sign in the pictures is greater than it actually would have been on the day of the accident.

5. As the pictures make clear, the vegetation that obscured the visibility of the stop sign becomes apparent the further away a member of the traveling public is from the intersection down the country roadway (Ford Wellpinit Road). The closer the traveler comes to the intersection, the impairment diminishes. In fact, in the two photos closest to the intersection, no impairment to the visibility of the stop sign is present. Also of significance, a traveler proceeding along SR 231 (the state roadway) would not be alerted to any impairment caused by the vegetation along the county roadway.
