BRIEF OF RESPONDENT STEVENS COUNTY

**Safety Report
Walker v. Washington State Department of
Transportation**

**Prepared by: Carl Berkowitz, Ph.D., PE
August 27, 2018**

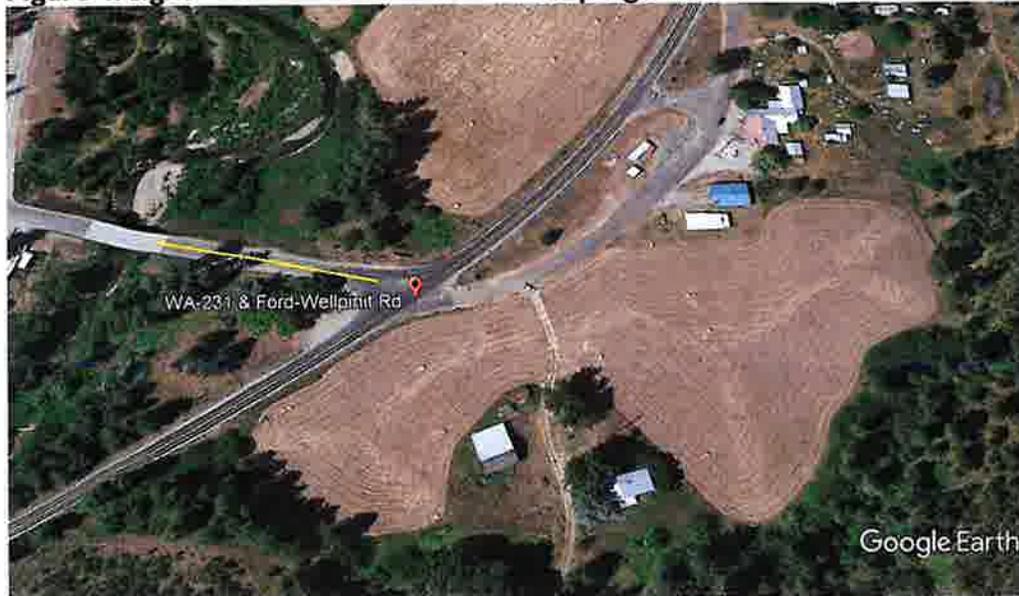
Figure 4: sight distance of 325 feet from stop sign

Note: position of 325 feet from stop sign

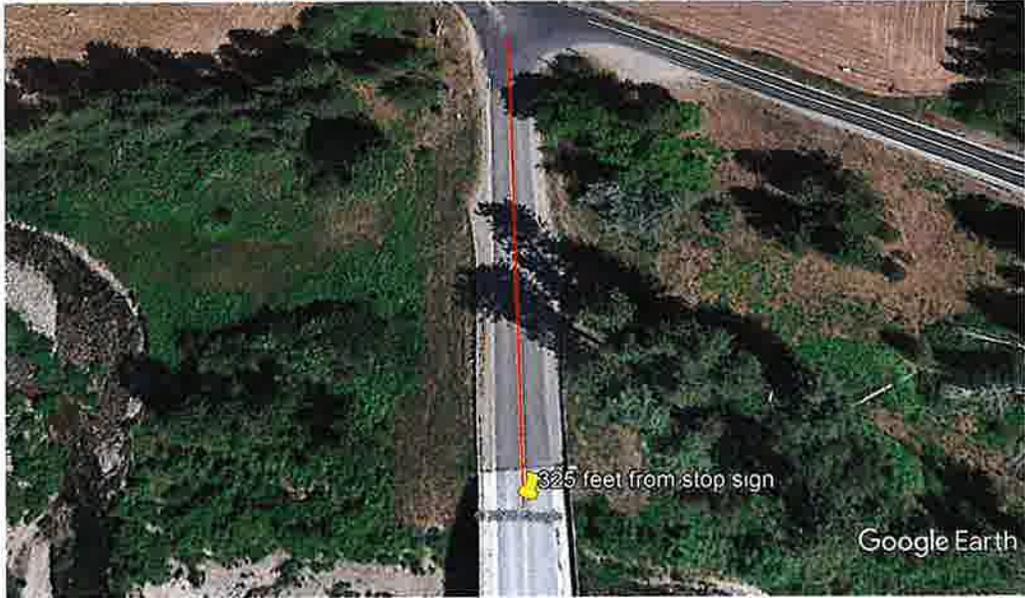
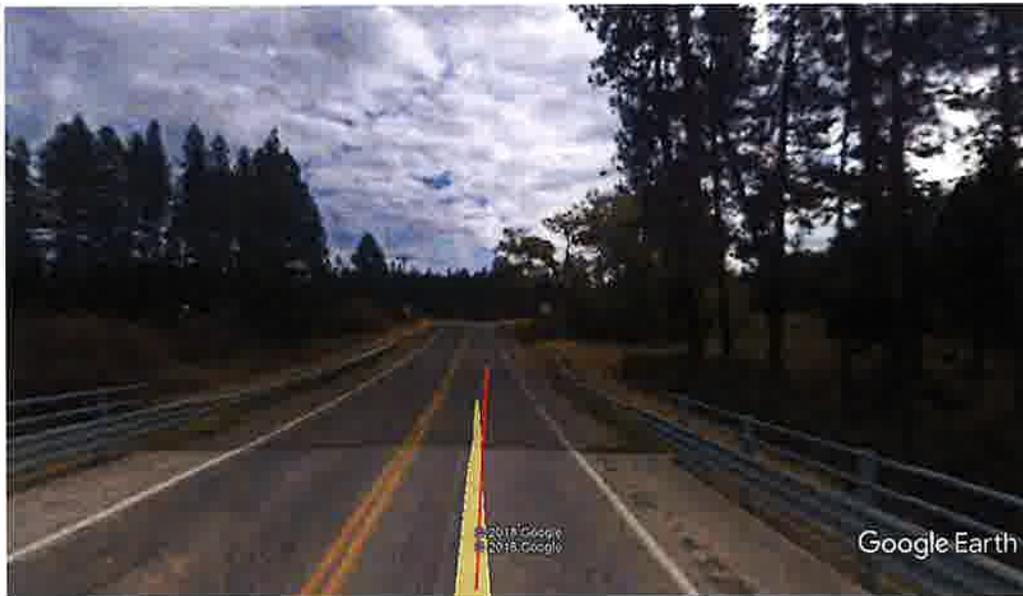
Note: View 325 feet from stop sign

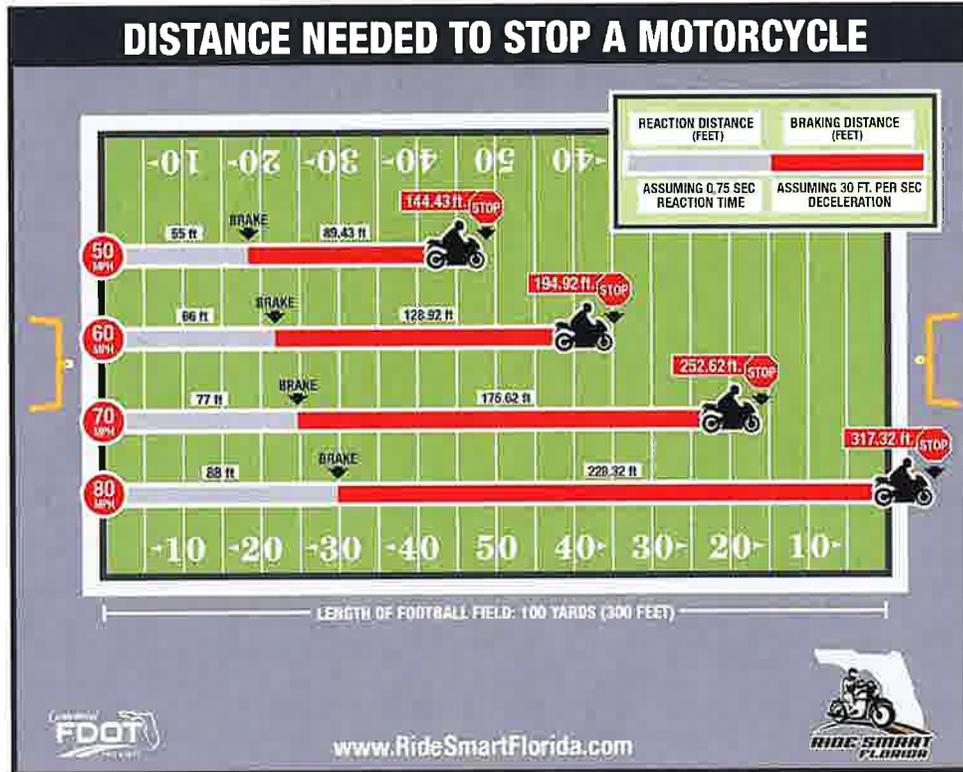
Figure 5: Motorcycle stopping distance

For more information, please see "A Study of Motorcycle Rider Braking Control Behavior (2011)" by the NHTSA

Note: At 50 mph: reaction brake time is 0.75 seconds, braking stop time is 2.44 seconds. Total time is 3.19 seconds.

motorcycle traveling at 50 mph needs approximately 143 feet and 3.19 seconds to stop. According to the report this distance includes 55 feet reaction distance and 89.43 feet braking distance. This is consistent with a study by bikesafer.com (with Montreal Promocycle Foundation),⁵ which calculates the braking distance with ABS brakes and reaction time is 141.64 feet and 3.24 seconds to stop. It is possible that Mr. Walker's lack of experience with his high-performance motorcycle contributed to the accident. The operators of this type of motorcycle tend to lean forward over the handle bars for a more aerodynamic profile, which can reduce the sight distance. (see photographs of similar motorcycles in figure 9) However, in each of these scenarios, it is clear that Mr. Walker had sufficient sight distance to stop before entering the intersection. In this case, given the other vehicle was obeying the required traffic laws, Mr. Walker would be at fault for the accident for not complying with the applicable traffic laws.

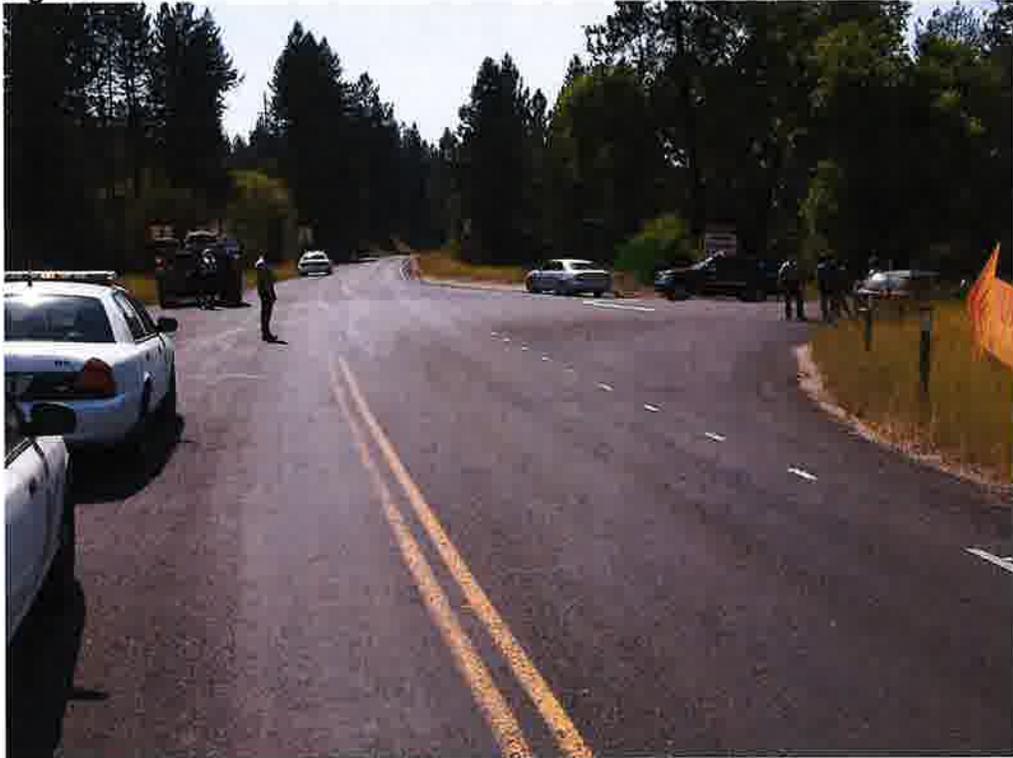
Figure 7: Visual cues of intersection

Note: White line that divides State Road 231 from Ford-Wellpinit Road

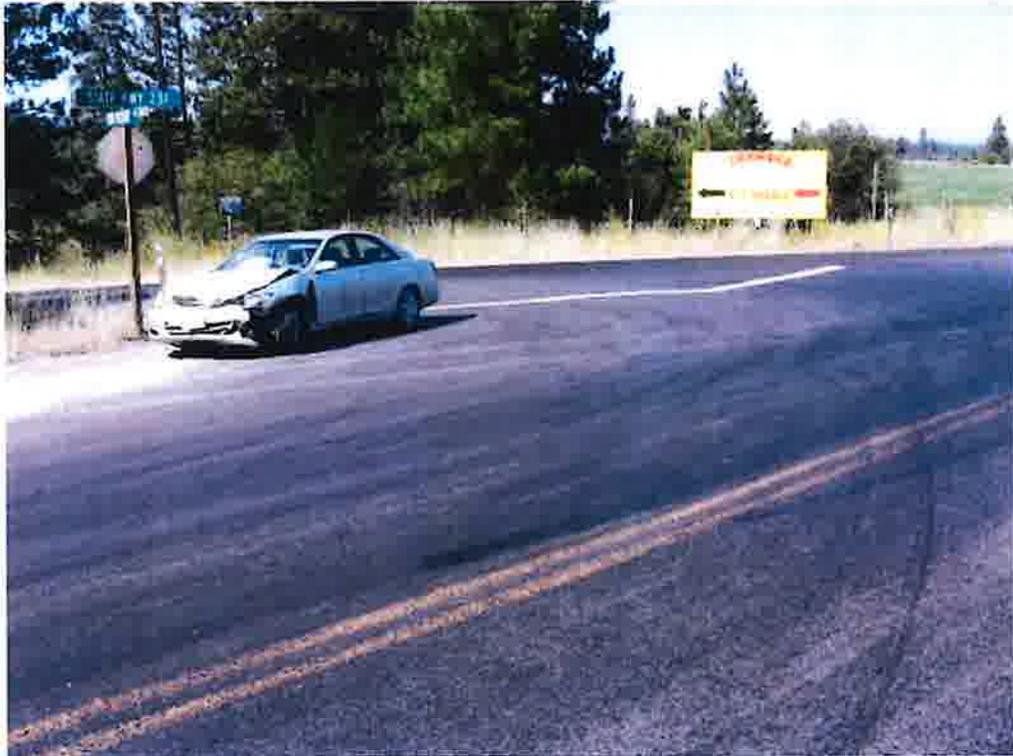
Note: Freshly painted stop bar⁸

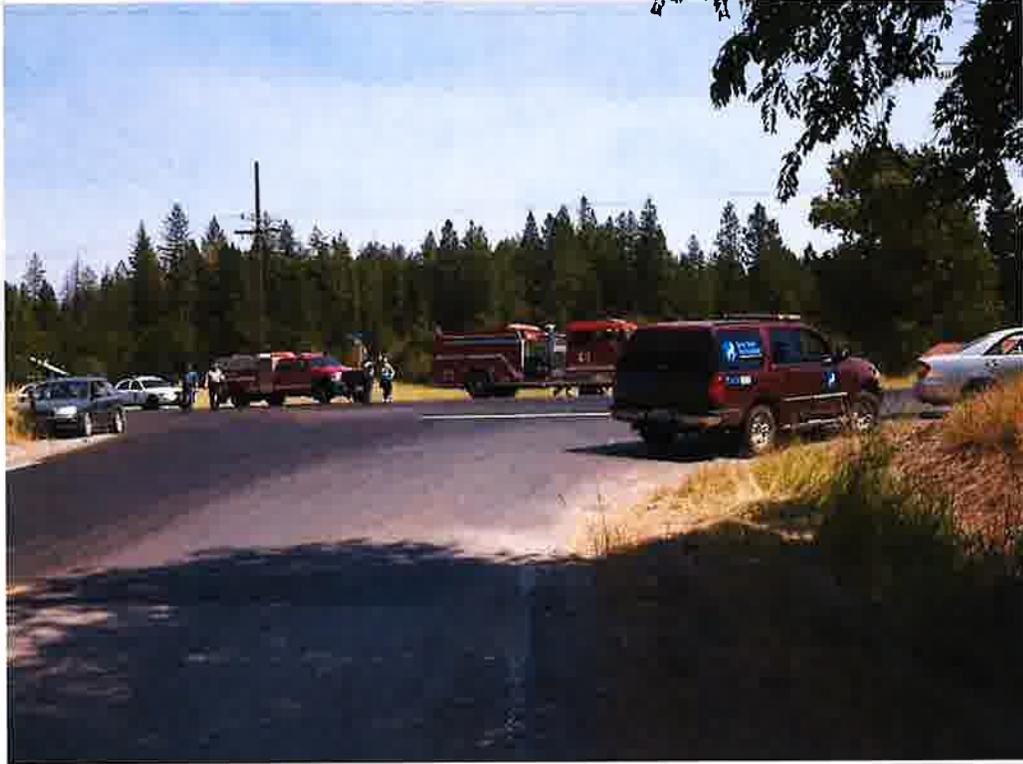
Note: Freshly painted stop bar

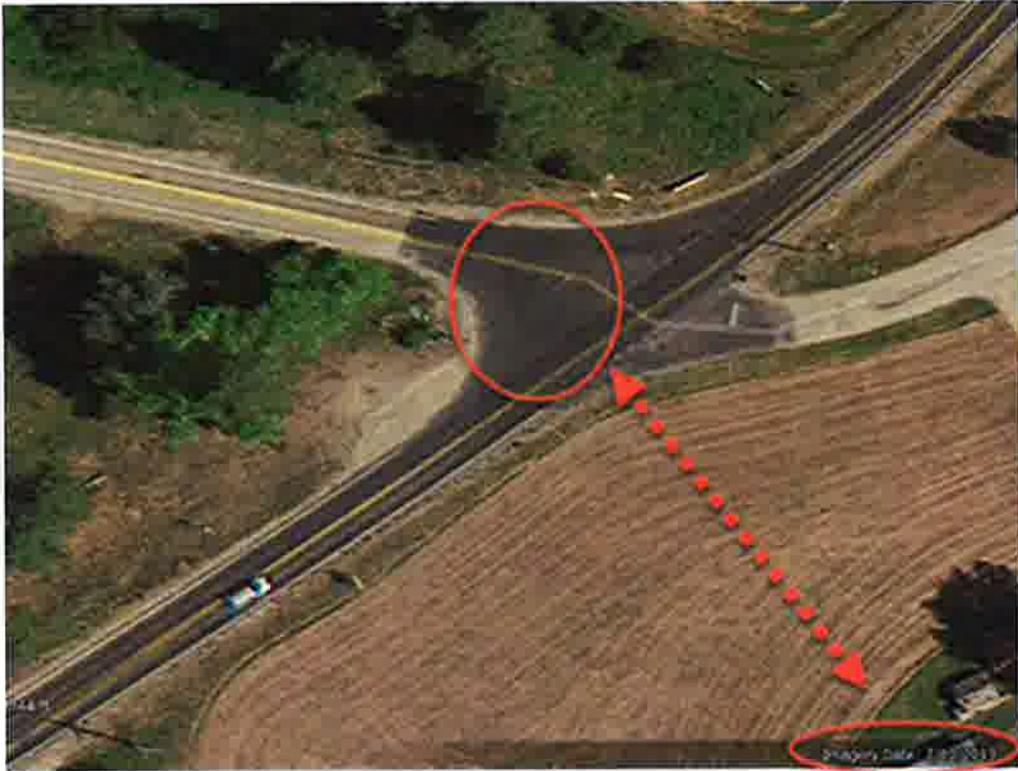
Note: Historic view dated July 13, 2013 (before accident) which shows a very worn stop bar, indicated that the stop bar was freshly painted prior to date of accident on July 26, 2013.

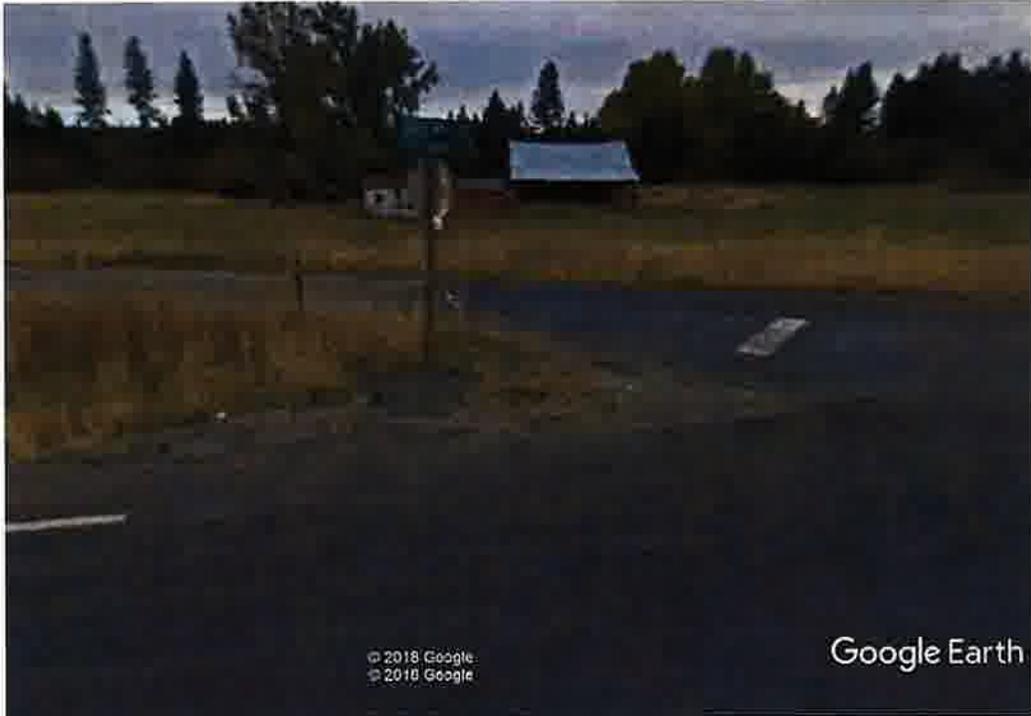
Note: Stop sign and stop bar on opposite side of the intersection⁹

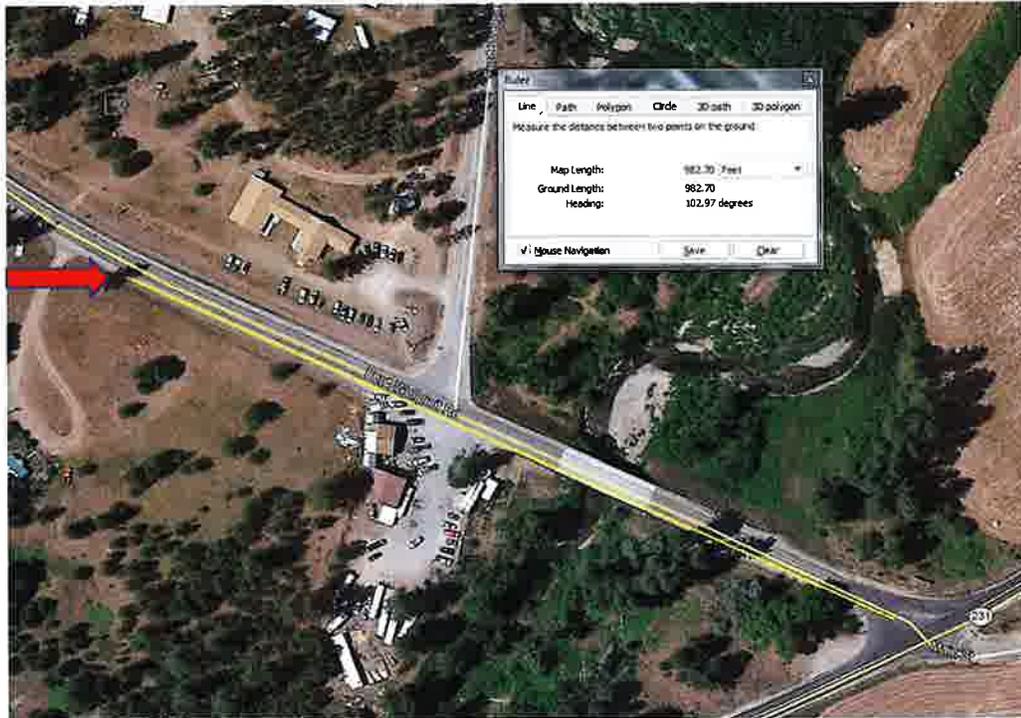
Note: Aerial view showing position approximately 980 feet from stop sign

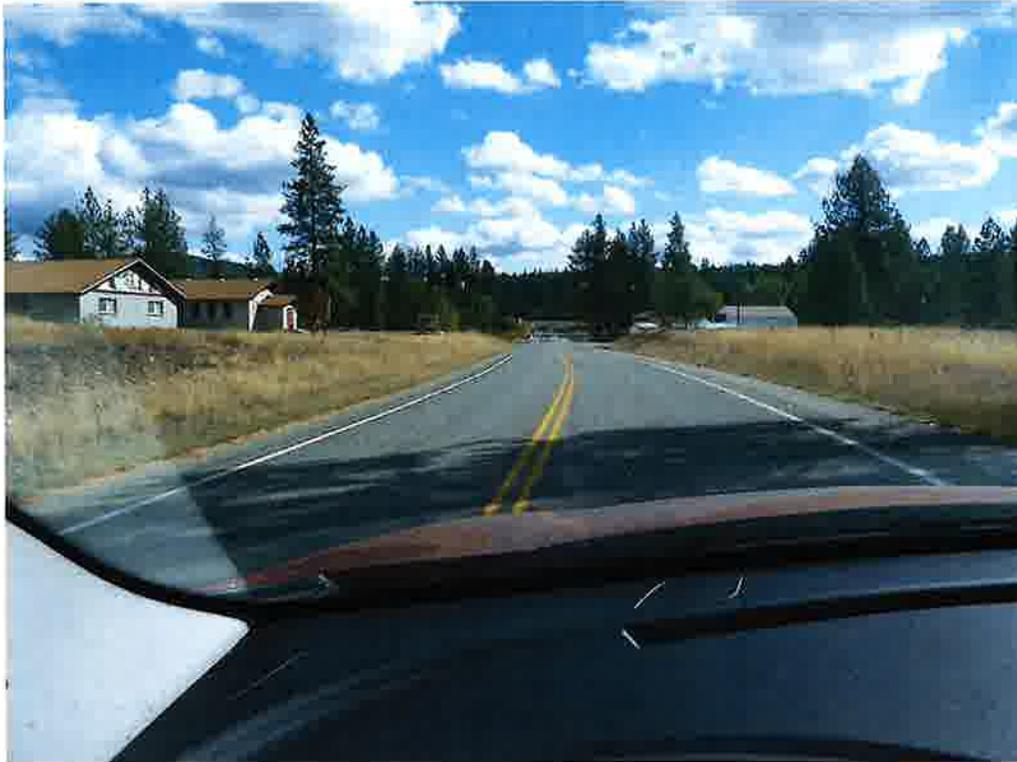
Note: Mr. Walker view approximately 980 feet from stop sign

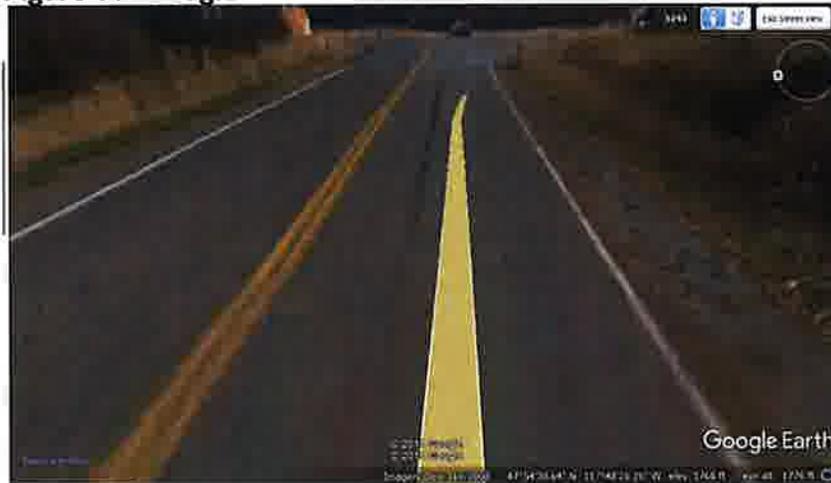
Figure 10: Google Earth elevation calculations

Note: elevation = 1768 ft

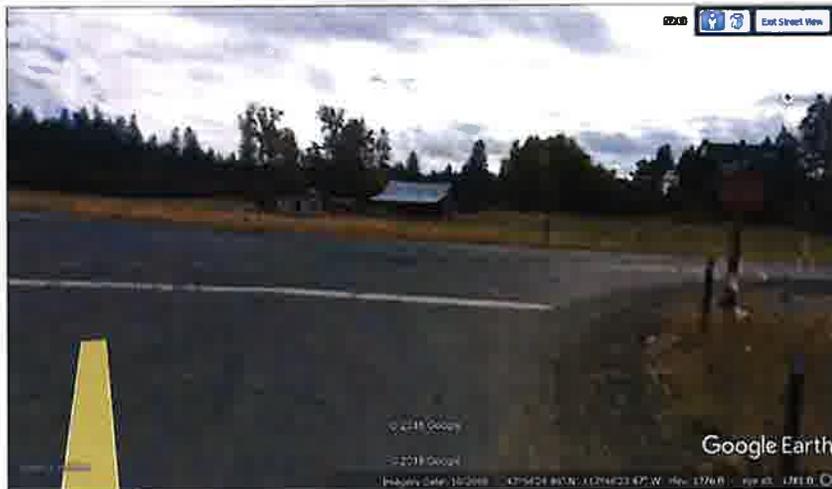
Note: elevation = 1776 ft

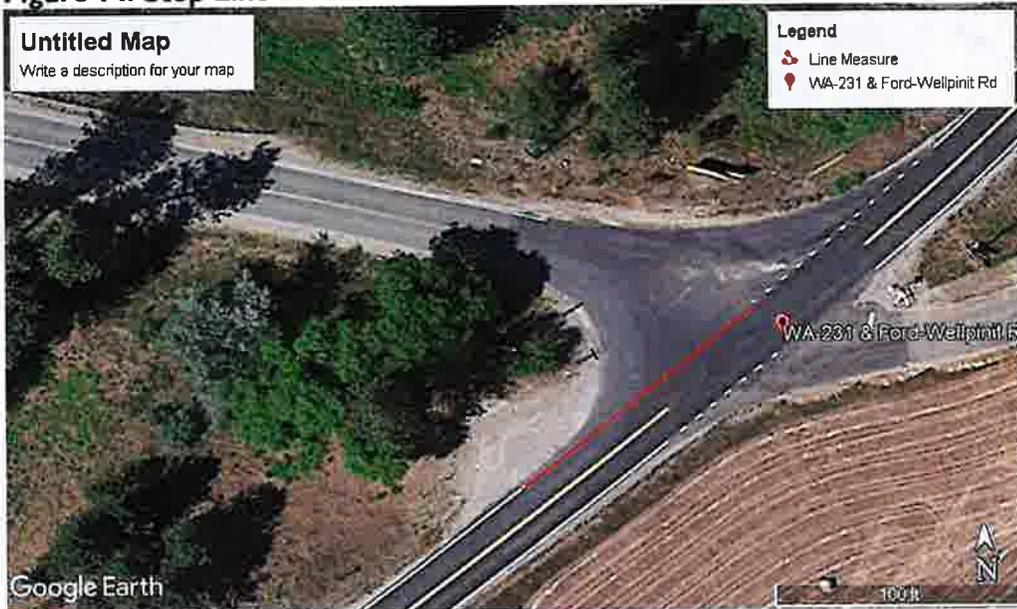
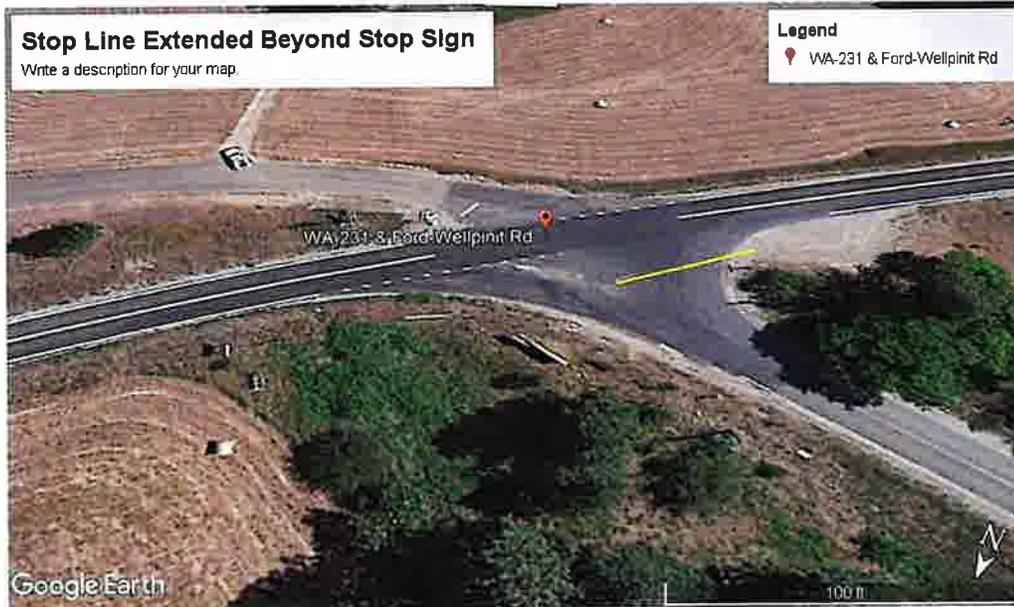
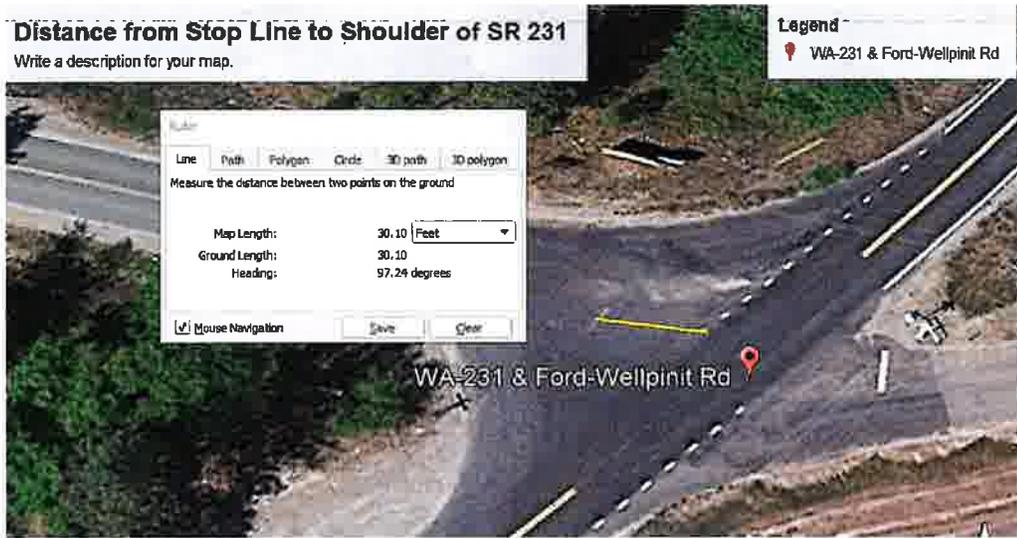
Figure 14. Stop Line in relation to SR 231 extended shoulder line

Furthermore, if Mr. Walker had slowed his vehicle to stop at the stop line or at the shoulder line, Ms. Alvarez who was traveling at 50 mph would have past the point where Mr. Walker would have intersected with SR 231.

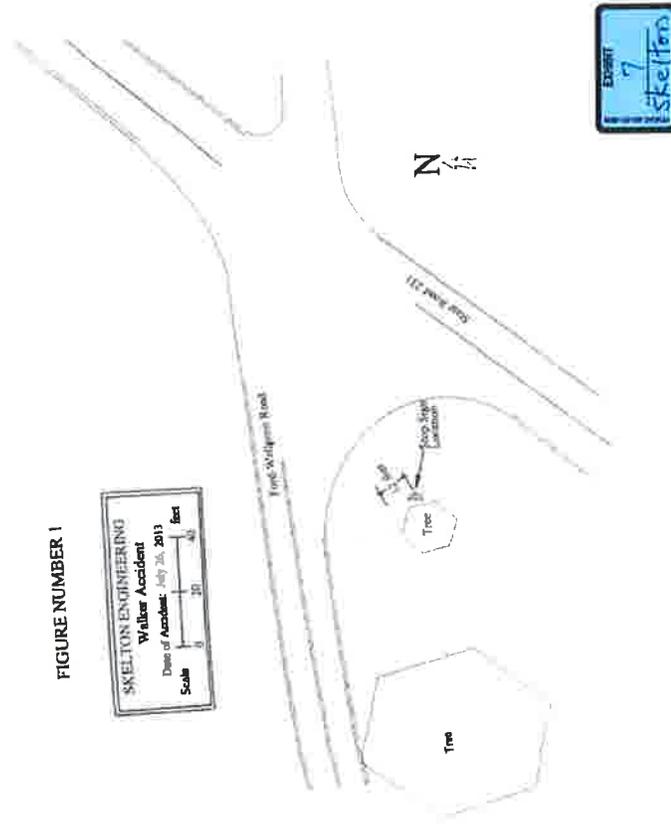
FIGURE NUMBER 1

Trees and vegetation blocked the view of the Stop Sign for approaching traffic until the traffic was only approximately 125 feet from the stop sign. The brush that was taller and higher than the stop sign and grew to within fifteen feet (15') of the stop sign totally obscured the view of the stop sign until approaching traffic was approximately 125 feet from the sign.

SKELTON ENGINEERING
Walker Accident
Date of Accident: July 26, 2013
Scale 0 20 40 feet

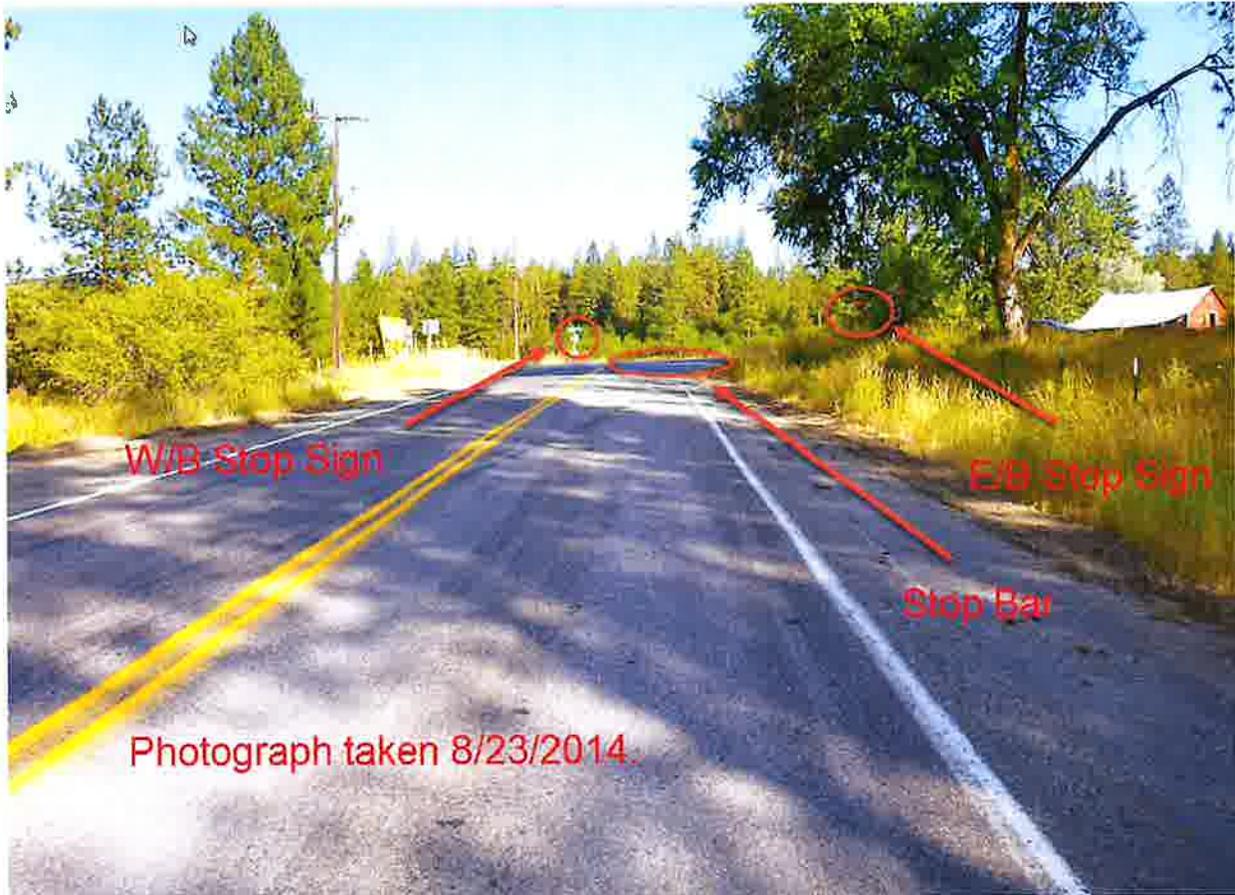
The image above was taken on August 23, 2014 and is labelled P1020764 from Walker photographs. The location of the photograph appears to be between 210-230 feet west of the stop bar for eastbound traffic.² The image was taken from the right wheel track and both stop signs (eastbound/westbound) and the eastbound stop bar can be observed. When comparing the Walker photographs with the scene images, there appears to be a growth to the bush that is just south of the green sign that was not evident in the scene images.

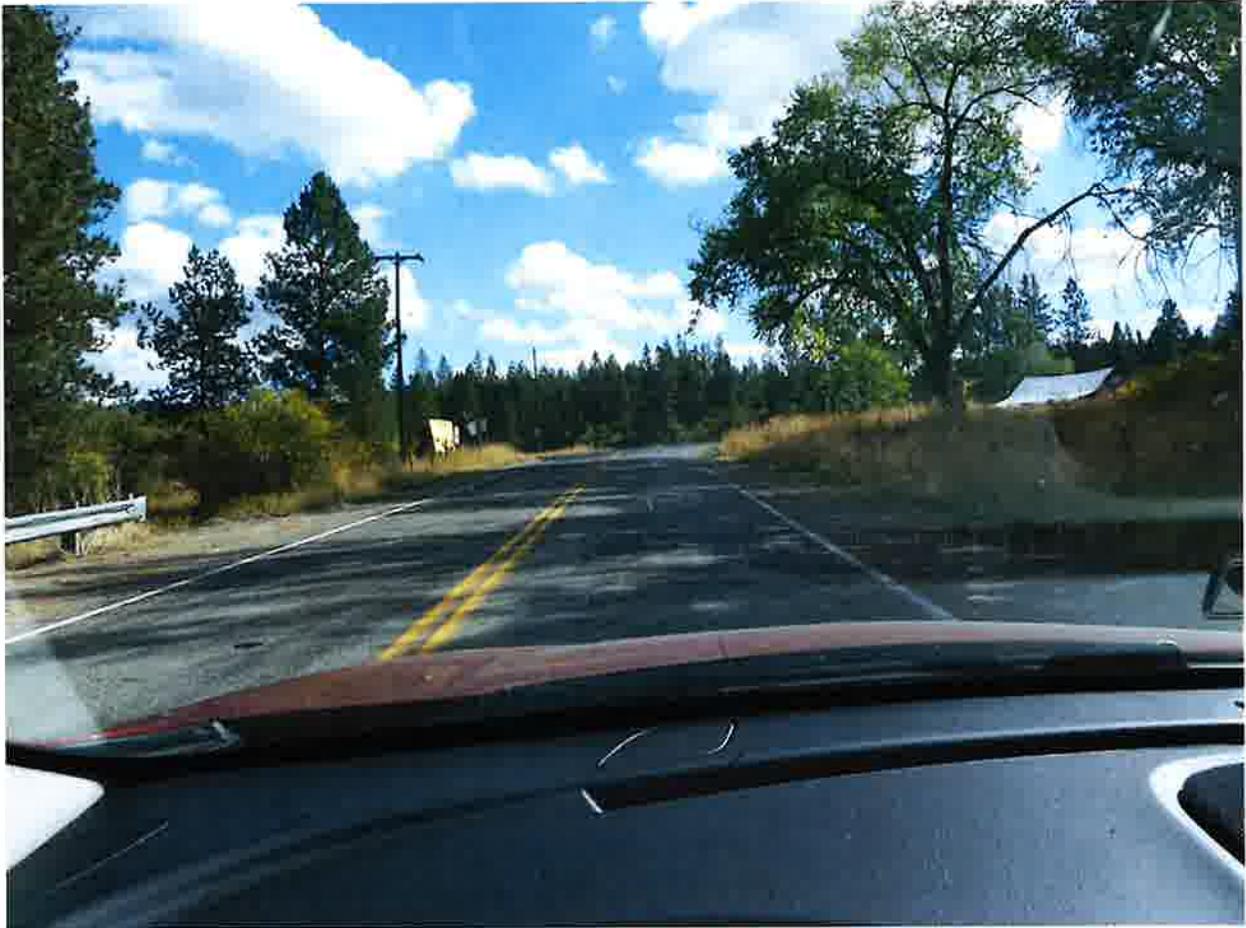
When I contacted the scene of the collision, I measured the dynamic sight distance (for a motorcyclist traveling in the left wheel track) to the stop sign based on the foliage as shown in the scene images and the Walker photographs that were taken over a year later. I determined the sight distance to the stop sign was in the range of 335 feet.

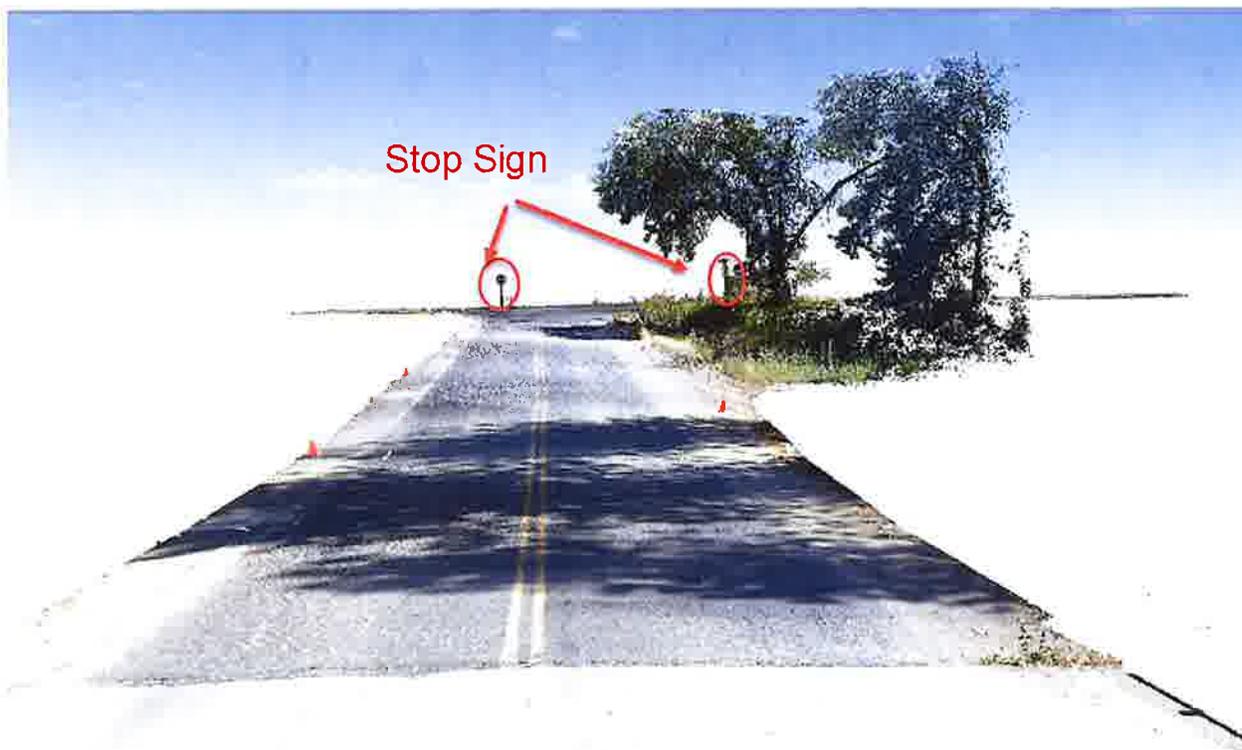
As part of the investigation, a 3-d scan of the scene was completed, and the excess foliage was removed in an attempt to duplicate the visibility of the eastbound stop sign at the time of the collision. A FARO scanner was used to document the roadway environment. The image below illustrates the approximate sight distance from the scan reconstruction. The actual dynamic sight distance was likely in the 325~ 350-foot range based on the simulated event.

It appears from the physical evidence that the stop sign was likely visible to Walker for well over 300 feet. This is consistent with the trooper's evaluation that the stop sign was "clearly" erected and the stop bar was "clearly" painted white.

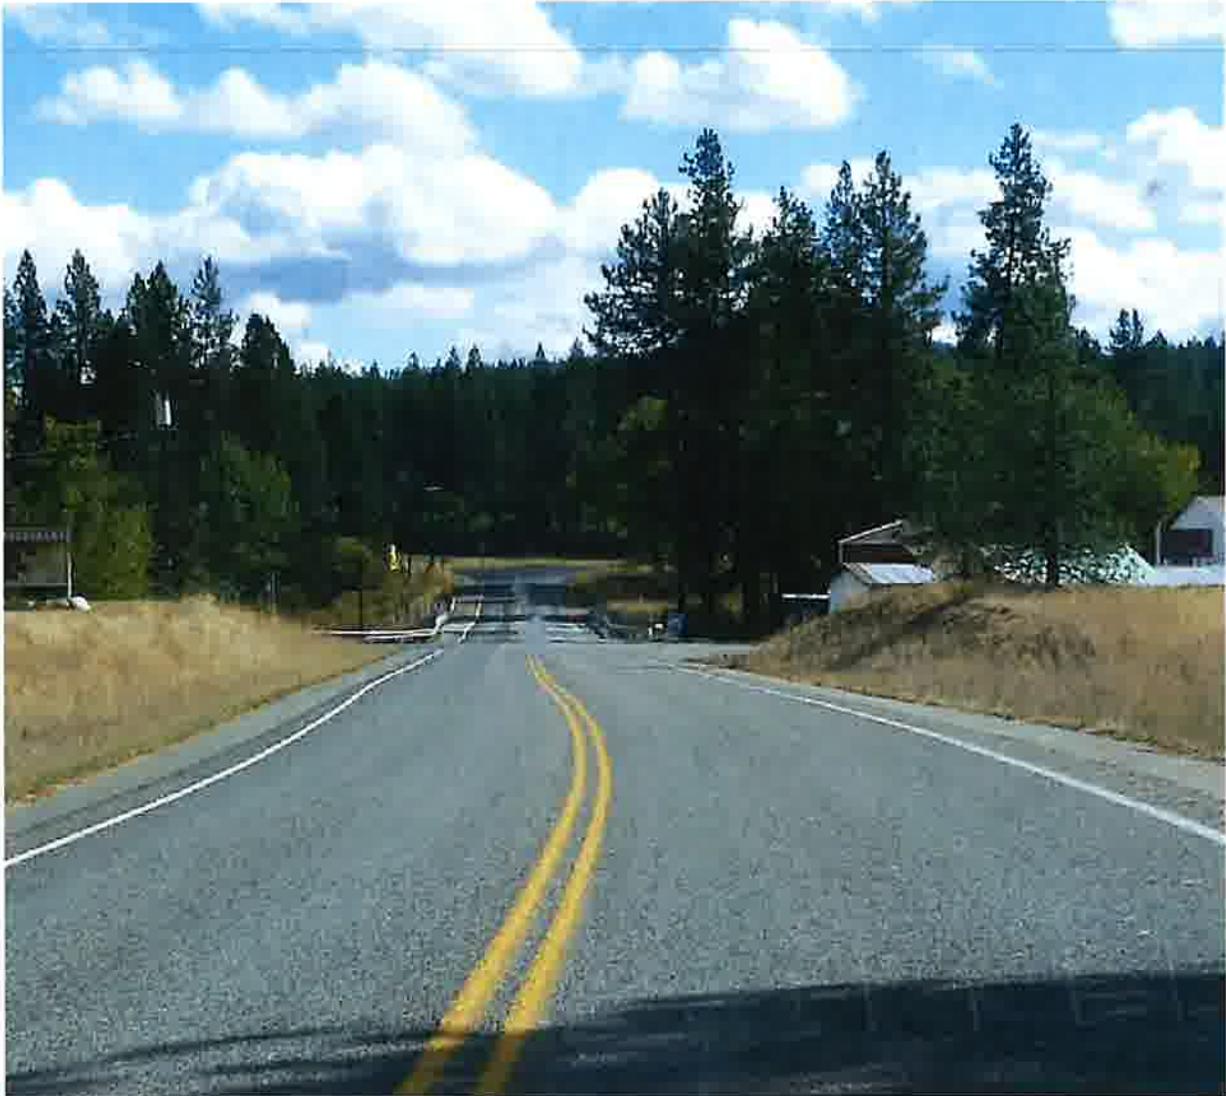
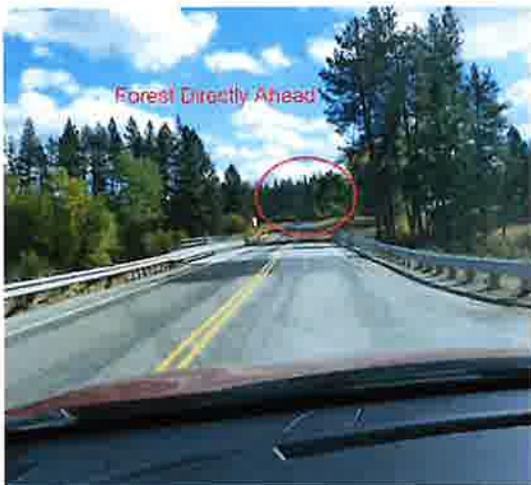
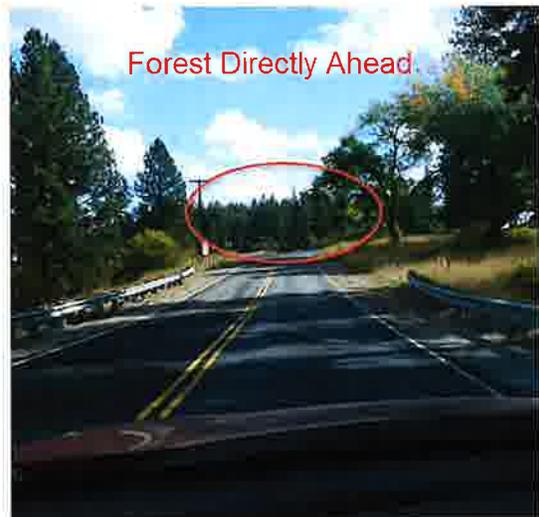
The approach photos show that the roadway is aimed directly at a forest of trees. Experienced motorcyclists are trained to watch tree lines to assist in determining the direction of the roadway. If the motorcycles were traveling at a constant speed of 50 mph. It would take them a little over 13 seconds to travel from the location 980 feet from SR 231, shown in the large photograph, to the stop bar.
